Re: Hope Valley Restoration and Aquatic Habitat Enhancement Project
General 401 Water Quality Certification WDID# 6A022004007
Annual Monitoring Report

Hope Valley Restoration and Aquatic Habitat Enhancement Project

2021 Annual Monitoring Report

Prepared by Mo Loden, Watershed Program Manager and Rachel Kieffer, Watershed Coordinator

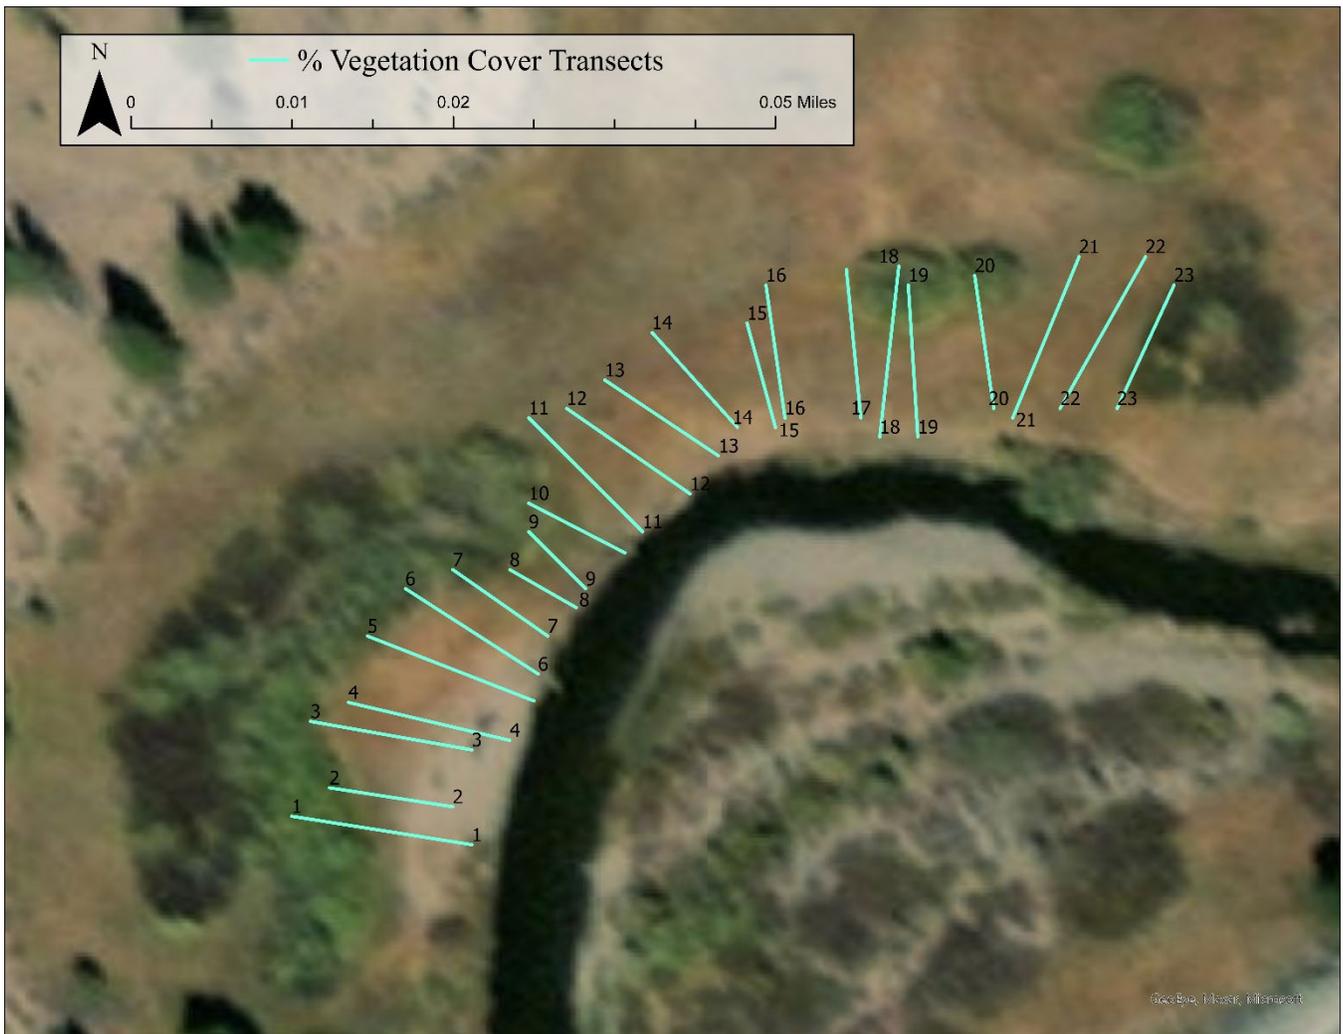
Figure 6: Site 1 Percent Vegetation Cover Transects

Percent coverage monitoring was established at Site 1 on June 17, 2019, at 23 transects and repeated the following years on June 21, 2020 and June 28, 2021. See Figure 6 and Table 3. Vegetation coverage was estimated within one square yard at 11 monitoring points evenly spaced along 15-meter-long transects. In 2019, some transects were marked with a medium-size nail in the meadow at the meadow edge farthest from the riverbank to assist with relocation of marked transects. Unfortunately, either the nails were found and removed by a Hope Valley visitor, which is highly likely due to the ease of access and popularity at the site, or the combined use of AWG’s Garmin GPS 64st and PYLE-SPORT PMD38 metal detector were not adequate enough to locate most markers. June 2020 data collections were based solely on GPS coordinates to relocate transects, as will future years be.

Subject matters not considered when percent coverage goals were set is the increased surface area in the newly created floodplain bench and difference in plant species. The U-shaped floodplain bench constructed at Site 1 formed approximately 30% more surface area than the mostly flat meadow ground that existed before the project. The salvaged sod was strategically placed back in the bench to offer the most coverage available. Additionally, the pre-project meadow surface was primarily covered by grasses, but it now has been filled vigorously with willow shrubs and stakes which may affect how grasses take root in this area. It is also noteworthy that the 90% coverage goal was set after collecting just one year of transect data (2019); 2019 was a particularly wet winter with snowmelt into Hope Valley continuing well into July.

The Monitoring Plan (Appendix A) called for at least ten transects to be selected for Site 1 vegetation monitoring. In attempts to be thorough, to not miss any major area of the unbuilt bench, and to provide as much data as possible, more transects than necessary were monitored in June 2019 and June 2020. The project team may choose to scale the vegetation monitoring down to no less than ten transects in following years. Vegetation monitoring yearly goals in conjunction with photo monitoring will help the project team assess if further revegetation work needs to be done.

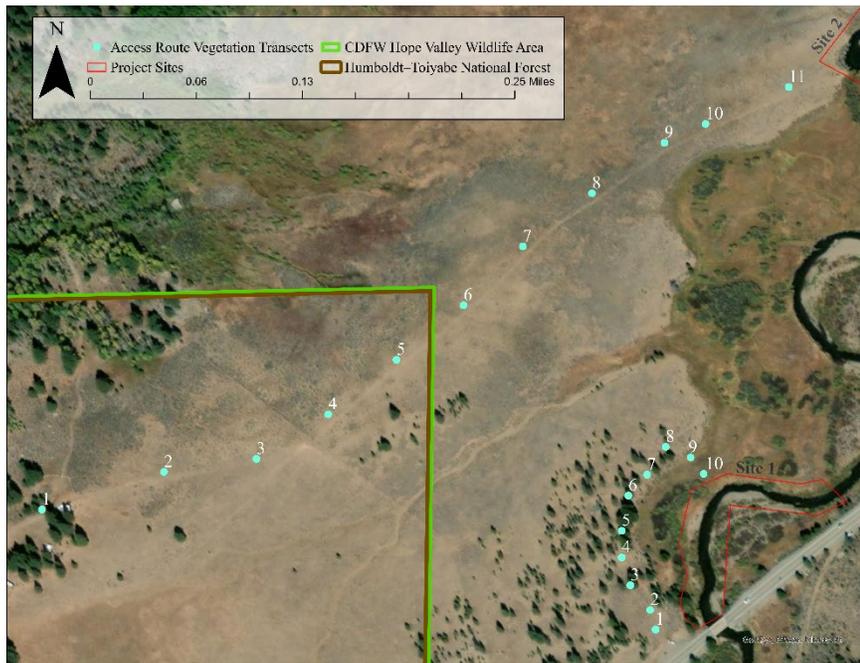
Figure 7: Site 1 and Site 2 Access Routes' Percent Vegetation Cover Transects

along each route. Access routes were selected to cause the least amount of impact by using paths in dry and minimally-vegetated areas. Access route percent coverage monitoring was repeated on June 28, 2021 to better align with other project vegetation data collections and peak phenology and therefore shows higher percent coverage. Concerns about Site 2’s access route use was brought up during the project’s September 28 pre-construction kickoff meeting. During this meeting, the access route was observed as rutted and sparsely vegetated in the tire tracks—far more than expected since its last permitted use for the American Rivers 2015 log crib project. It is assumed the route has been experiencing unauthorized vehicle use and, consequently, the route

conditions were considered impacted before AWG’s project implementation began. See Appendix C to view a Google Earth analysis showing how the access route was displaying signs of self-healing after the 2015 log crib project up until August 2019. Additional unauthorized vehicle use was observed across the meadow in Hope Valley on August 19, 2021. These tracks were reported to appropriate CDFW staff and are not believed to be related to the 2020 instances. However, the Site 2 unauthorized vehicle use observed in 2020 does not appear to be a continued problem at this time. Google Earth analysis from 2021 does not show an increase in disturbance and further indicates that this may not be a continuing issue.

At Site 2 access route, transects 1-5 are on USFS land and transects 6-11 are on CDFW land. AWG’s project team, with USFS and CDFW landowners, agreed to restore Site 2’s access route

to pre-project conditions as found on September 28, 2020. The agreed-upon approach to restore Site 2's route was to use a water truck to emulate a rain event and then provide selective hand-raking that protected the sparse vegetation already established in the wheel wells while further camouflaging the path. This technique dissolved the tire tracks caused by AWG's project, but it did not remove the rutting that existed prior to project commencement. AWG staff will continue conversations with the USFS Rangeland Biologist who manages the grazing lease in Hope Valley to try to identify responsible parties and then stop the detrimental use of the route. Achieving pre-project conditions or better at Site 2 may be unattainable if the access route continues to receive the amount and type of use that has transpired since summer of 2019.
