Re: Hope Valley Restoration and Aquatic Habitat Enhancement Project
General 401 Water Quality Certification WDID# 6A022004007 Annual
Monitoring Report

Hope Valley Restoration and Aquatic Habitat Enhancement Project

2025 Annual Monitoring Report

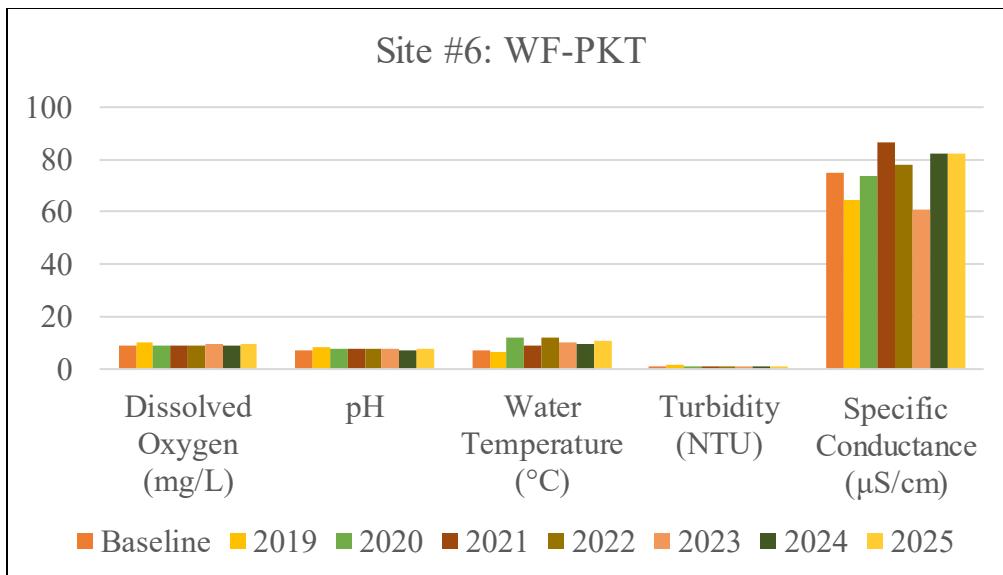
Figure 3: Water quality data summary for West Fork-Picketts Junction (WF-PKT)

[‡]Data corrections were made due to errors found in past published reports from 2021, 2022, 2023, and 2024. These corrections are also reflected in Figures 3 and 4. All data tied to Figures 3 and 4 have been thoroughly reviewed, corrected, and updated in this 2025 report.

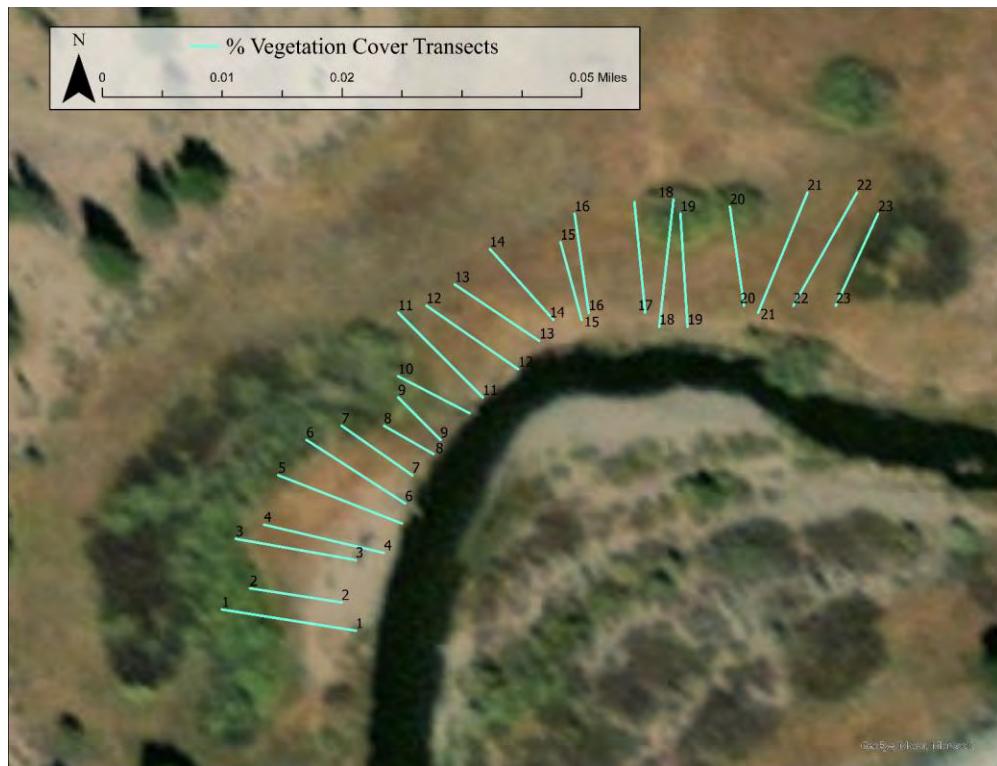
Figure 6: Site 1 percent vegetation cover transects

July 2023 due to water still inundating the site. The percent goal for 2024 of 90% was not met at Site 1 based on June 2024 monitoring. Percent coverage monitoring was conducted again in June 2025, and the pre-project percent coverage of 90% was again not met.

Due to the factors discussed above—eroding shoreline, missing nails meant to assist with locating transects/relying on GPS coordinates with a +/- 49 ft accuracy, and an unrealistic pre-project vegetation coverage goal of 90%—Site 1 percent coverage has not met the desired goal as of June 2025, but there are also additional factors. AWG has experienced several staff changes throughout the life of this project which may have created a lack of consistency for estimating percent coverage; it has been observed and discussed internally that some AWG staff tend to be more conservative when assessing percent cover, while others are overly generous despite having the percent cover guidance sheet in the field for each monitoring instance. The reach of Site 1 runs adjacent to a popular “fisherman’s” trail and thus receives heavy traffic. The combination of eroding shoreline and heavy foot traffic alone causes the pre-project vegetation cover goal of 90% to be unachievable, and rerouting fishermen away from the river is not a viable option.

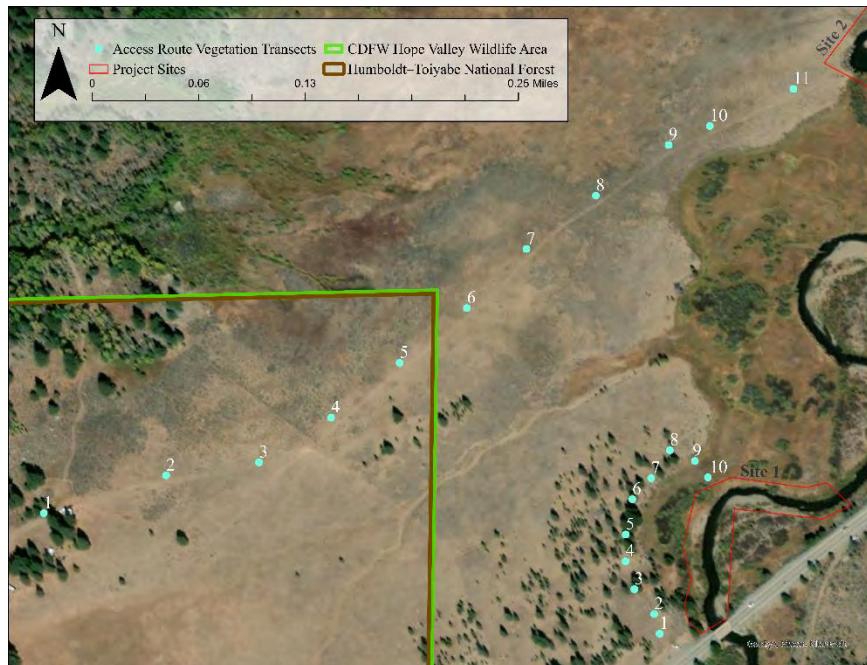
Figure 7: Site 1 and Site 2 access routes' percent vegetation cover transects

Access routes were selected to cause the least amount of impact by using paths in dry and minimally-vegetated areas. Access route percent coverage monitoring was repeated on June 28, 2021, to better align with other project vegetation data collections and peak phenology and therefore shows higher percent coverage.

Concerns about Site 2's access route usage were brought up during the project's September 28, 2020, pre-construction kickoff meeting. During this meeting, the access route was observed as rutted and sparsely vegetated in the tire tracks—far more than expected since its last permitted use for the American Rivers 2015 log crib project. It was assumed the route had been experiencing unauthorized vehicle use and, consequently, the route conditions were considered impacted before AWG's project implementation began. See Appendix C to view a Google Earth analysis showing how the access route was displaying signs of self-healing after the 2015 log crib project up until May 2021. Additional unauthorized vehicle use was observed across the meadow in Hope Valley on August 19, 2021. These tracks were reported to appropriate CDFW staff and are not believed to be related to the 2020 instances. However, the Site 2 unauthorized vehicle use observed in 2020 does not appear to be a continued problem at this time. Google

At Site 2 access route, transects 1-5 are on USFS land and transects 6-11 are on CDFW land. AWG's project team, with USFS and CDFW landowners, agreed to restore Site 2's access route to pre-project conditions as found on September 28, 2020. The agreed-upon approach to restore Site 2's route was to use a water truck to emulate a rain event and then provide selective hand-raking that protected the sparse vegetation already established in the wheel wells while further camouflaging the path. This technique dissolved the tire tracks caused by AWG's project, but it did not remove the rutting that existed prior to project commencement. AWG staff continued conversations with the USFS Rangeland Biologist who manages the grazing lease in Hope Valley to try to identify responsible parties and then stop the detrimental use of the route. Achieving pre-project conditions or better at Site 2 would likely be unattainable if the access route continued to receive the amount and type of use that transpired since summer of 2019 through 2020.
