Musser and Jarvis Watershed Restoration 2023 Monitoring Report

February 21, 2024

Musser and Jarvis Watershed Restoration Monitoring Plan

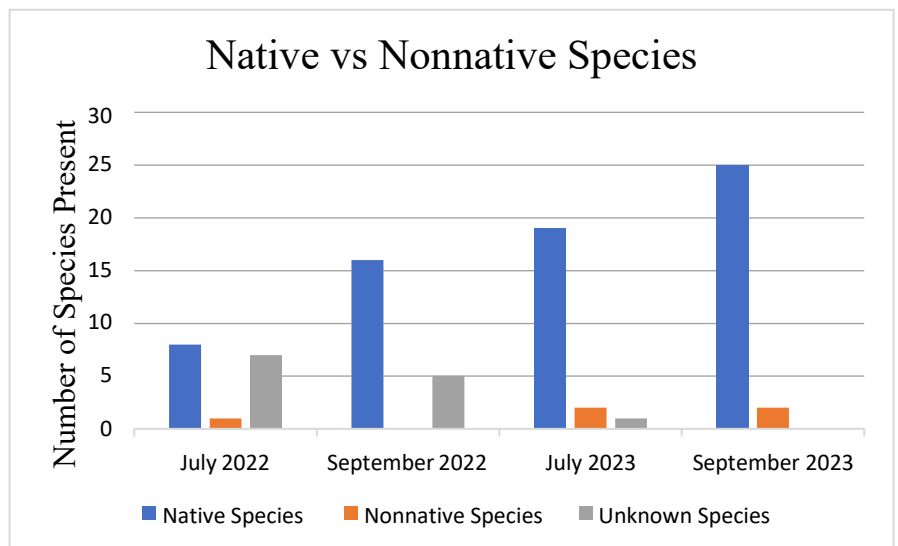
Figure 2: Native, nonnative, and unknown species present in 2022 and 2023

On July 5, 2023, 19 native species, 2 nonnative species, and 1 unknown species were found within the vegetation monitoring plots. September 27, 2023, had increased numbers of native species, decreased numbers of unknown species, and an unchanged number of nonnative species, with 25, 0, and 2 species respectively (see Figure 2). The average percent cover data between 2022 and 2023 reflects

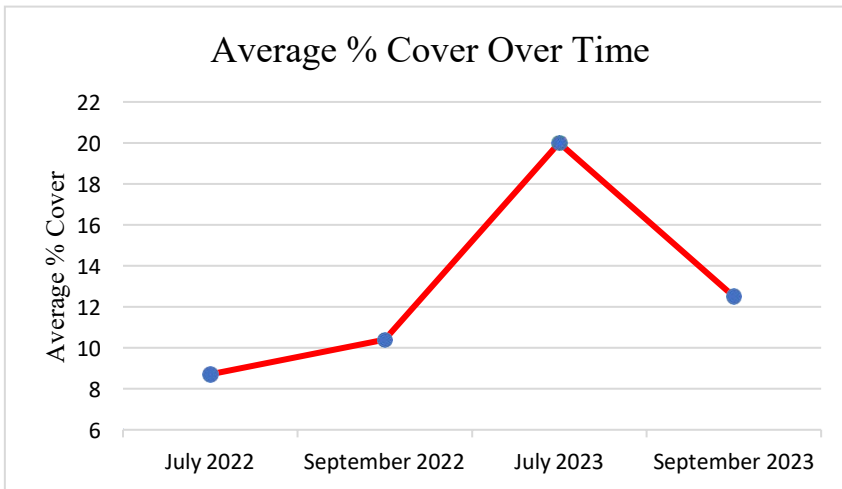
Figure 3: Average percent cover over time in 2022 and 2023

the changes seen in the photo points with an overall increase in average percent cover from 8.7% in July 2022 to 12.5% in September 2023 (see Figure 3). Out of the seeded native grass species, 5 were present. The two species of native grass that were not observed during the 2023 surveys were “Sodar” streambank wheatgrass (*Elymus lanceolatus*) and High Plains Sandberg bluegrass (*Poa secunda*).

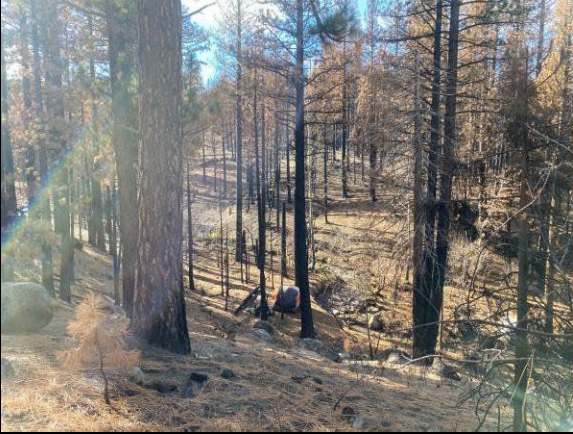
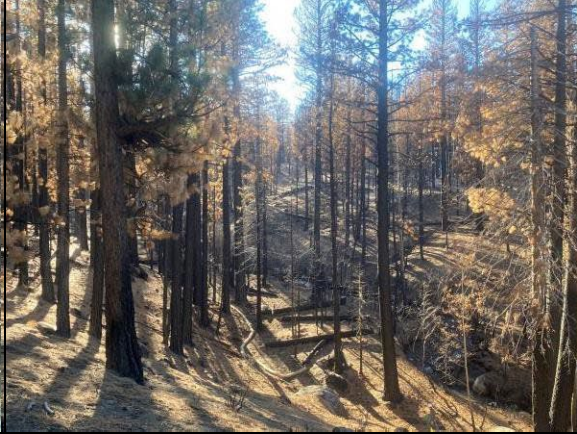
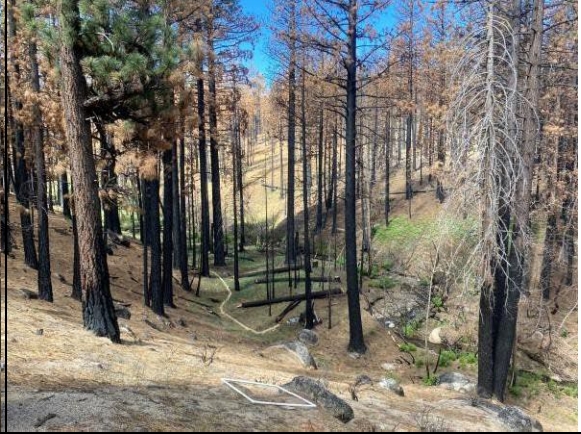
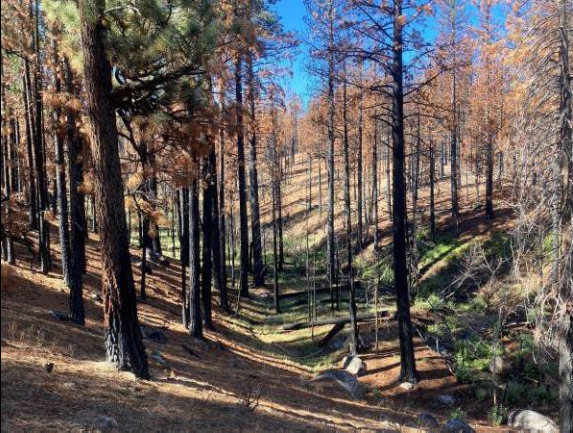
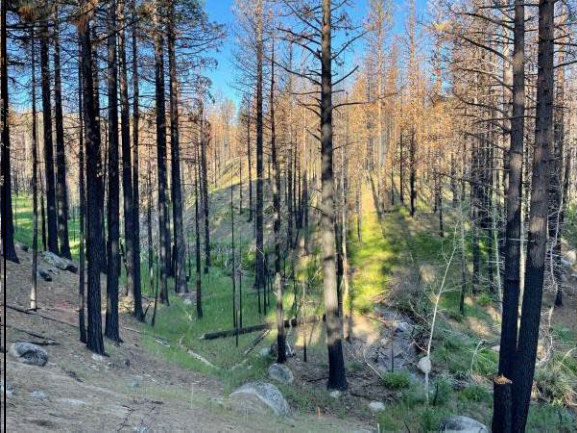
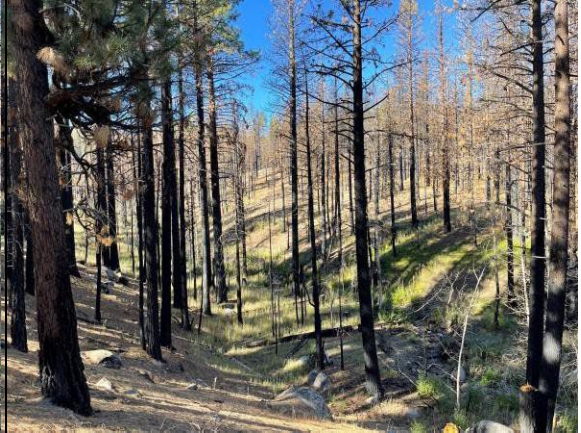
11/19/2021 (before treatment)	12/3/2021 (after treatment)	7/5/2022
MJPP1 (seeding with wattles)

Noticeable growth is detectable in both the seeded and non-seeded areas, with graminoids (herbaceous plants with grass-like features) being the prominent vegetation type in seeded areas and forbs in the non-seeded areas. Comparing the selected photo points demonstrates the most notable difference between September of 2022 and July of 2023, with September of 2023 seeing a slight regression of the graminoids as is typical in fall months (see Appendix B). Average percent cover reflects this same increase. The planted trees have persisted well to date, despite a significant growth of graminoids in the surrounding area as of September 2023, and growth is visible (for example, see MJPP

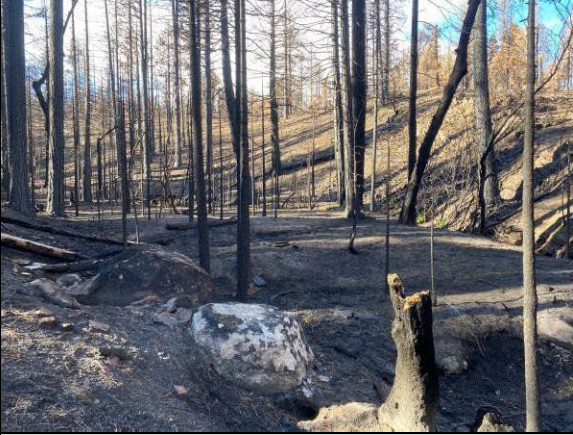
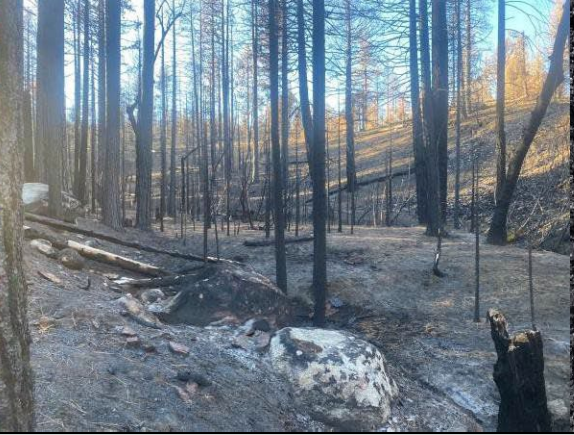
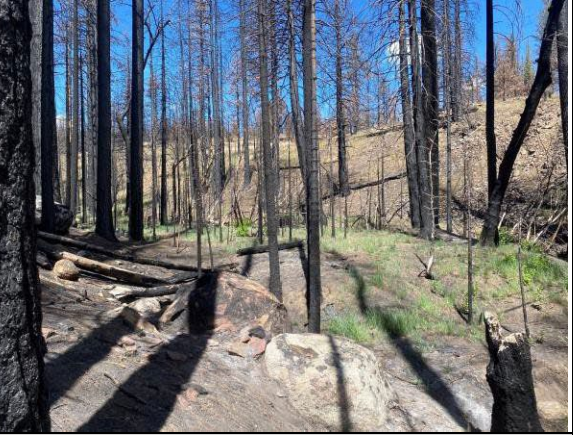
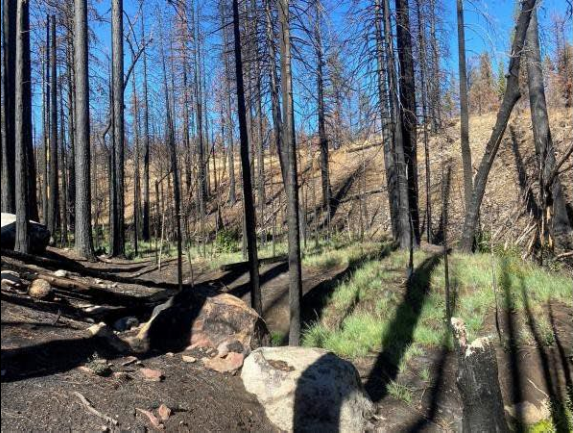
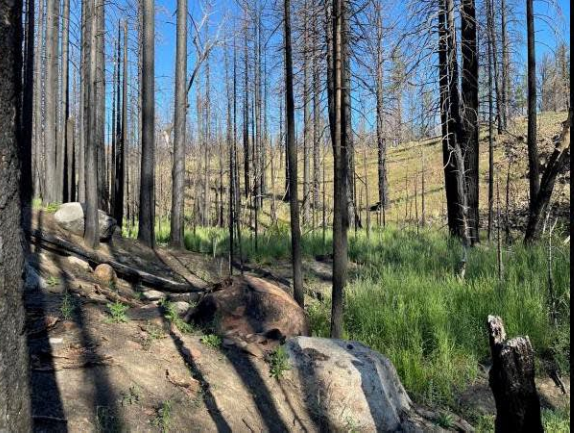
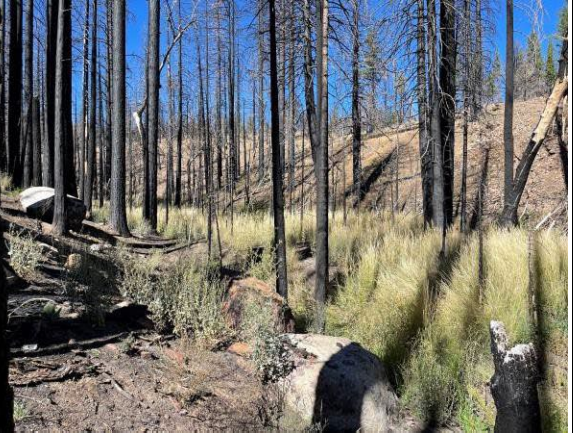
11/19/2021 (before treatment)	12/3/2021 (after treatment)	7/5/2022
MJPP8 (seeding without wattles)

9/22/2022	7/5/2023	9/27/2023

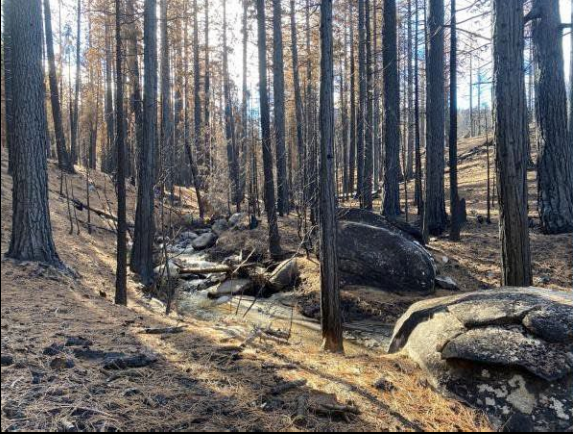
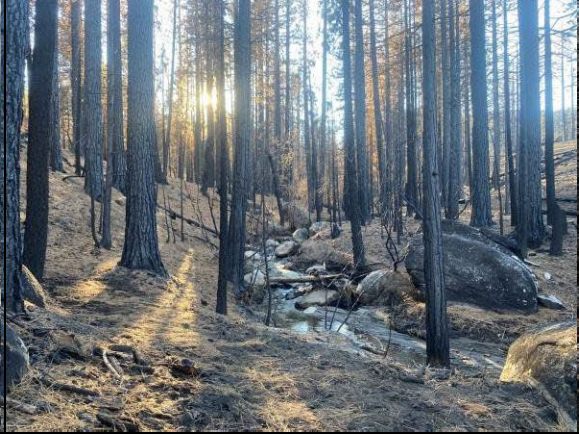
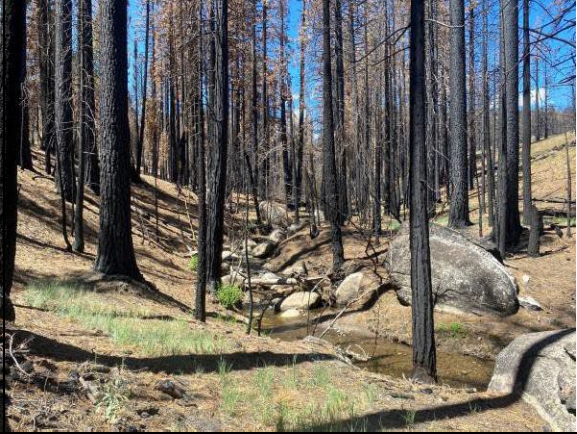
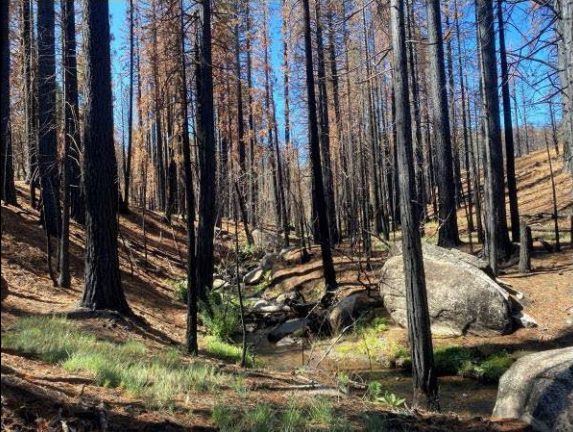
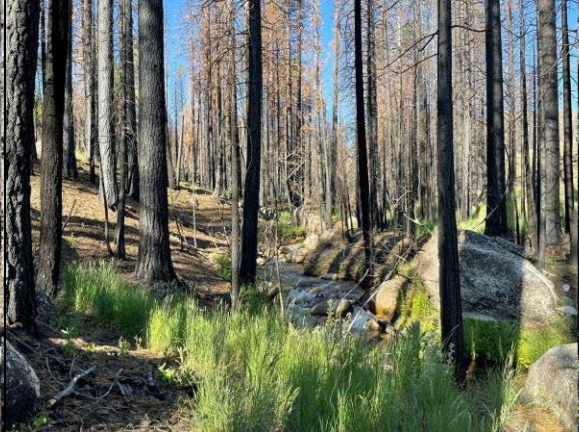
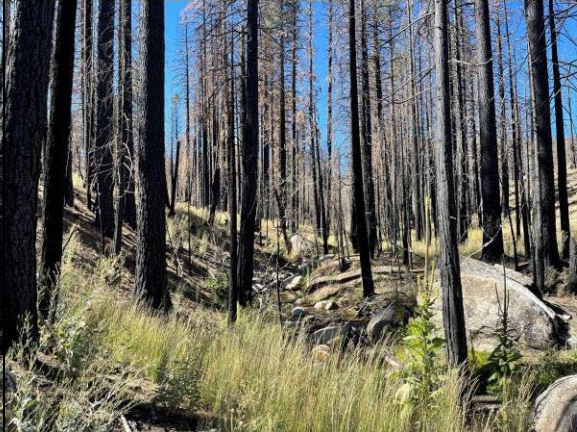
11/19/2021 (before treatment)	12/3/2021 (after treatment)	7/5/2022
MJPP10.1 (seeding without wattles)

9/22/2022	7/5/2023	9/27/2023

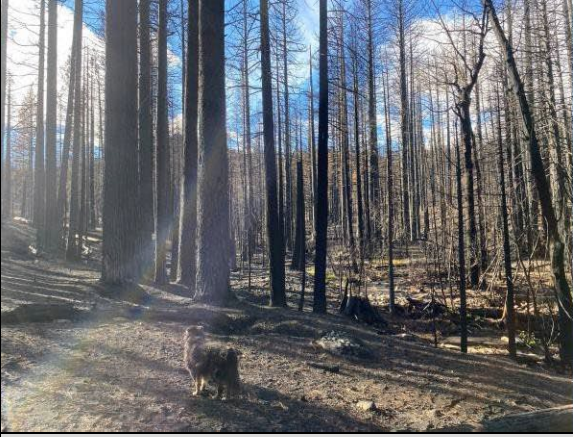
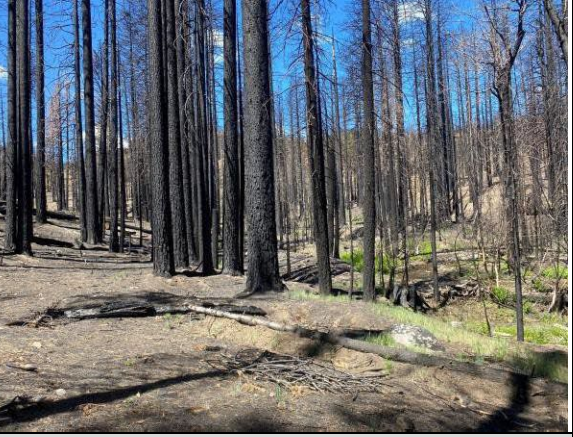
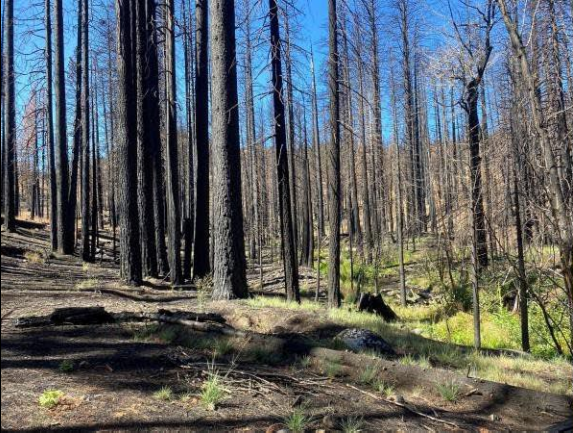
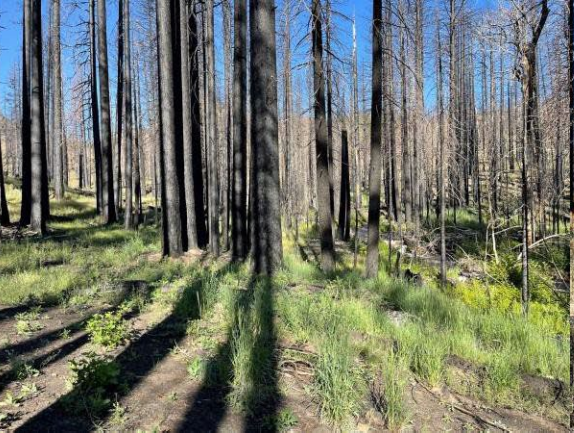
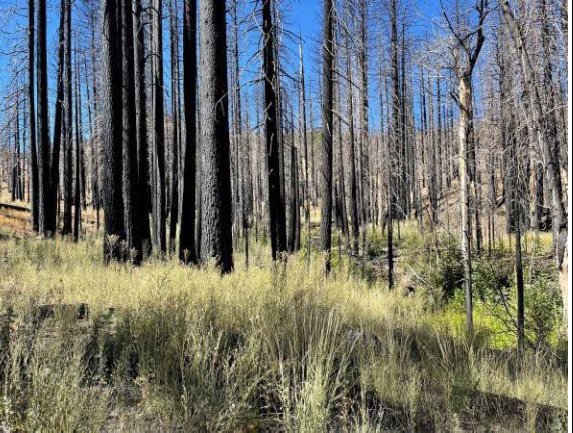
11/19/2021 (before treatment)	12/3/2021 (after treatment)	7/5/2022
MJPP12 (tree felling)

14 [July and September] in Appendix B). Soil has continued to settle behind the felled trees, encouraging graminoid growth between September of 2022 and 2023, and significant bank erosion has not been observed even with a significant storm event in August 2022 (see MJPP 12 in Appendix B) and the high-water year in winter 2022-2023. The south slope, despite little treatment, is recovering with few invasive species (see MJPP 19 and MJPP 20 in Appendix B).

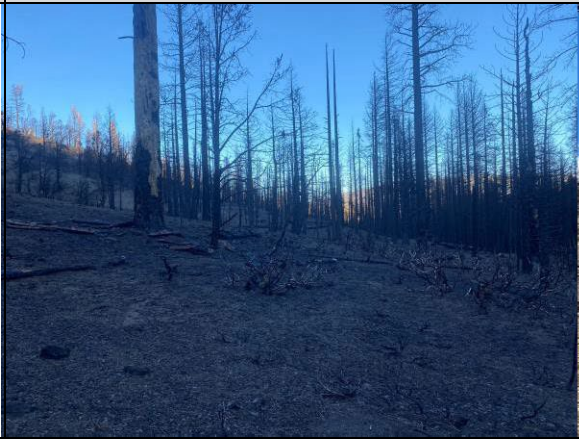
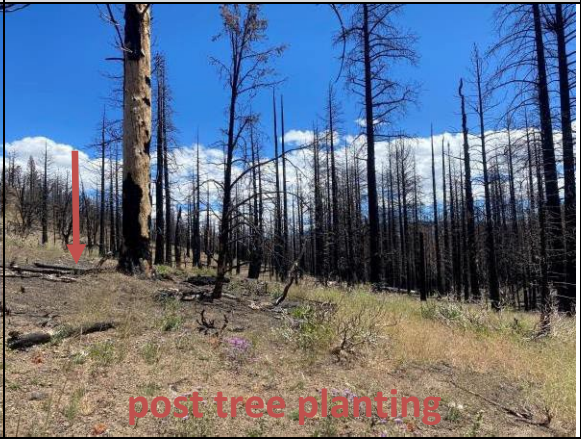
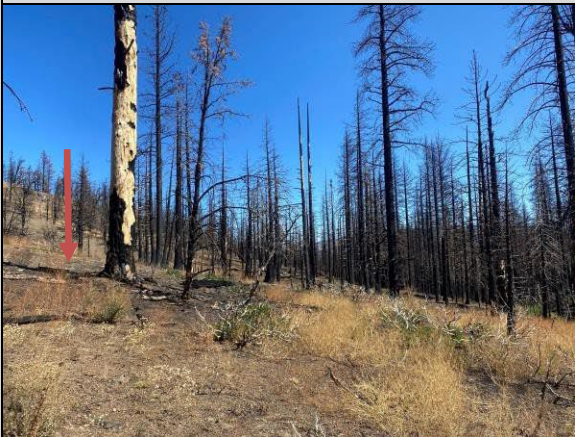
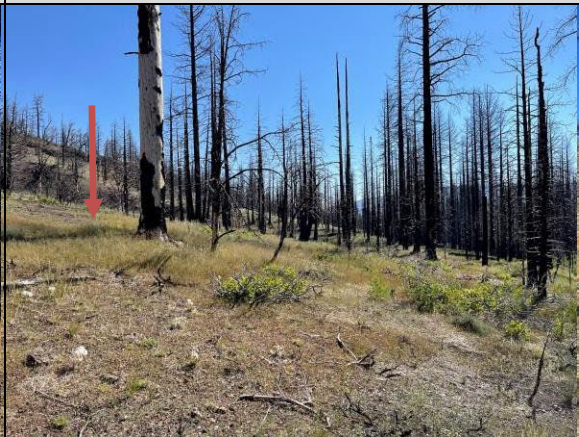
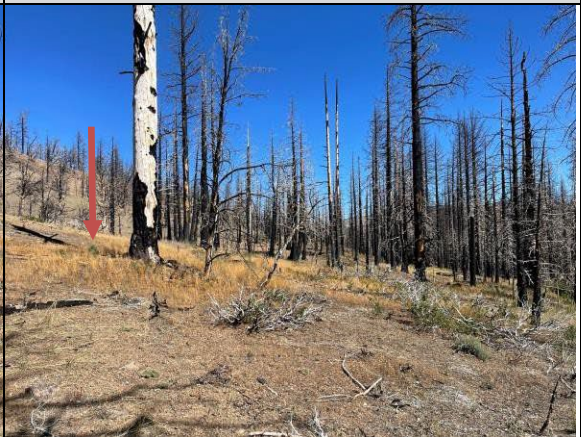
11/19/2021 (before treatment)	12/3/2021 (after treatment)	7/5/2022
MJPP17 (tree planting)	No photo taken

<p>post tree planting</p>
	9/22/2022	7/5/2023	9/27/2023
