# MUSSER AND JARVIS WATERSHED ASSESSMENT REPORT

January 24, 2025

ALPINE WATERSHED GROUP

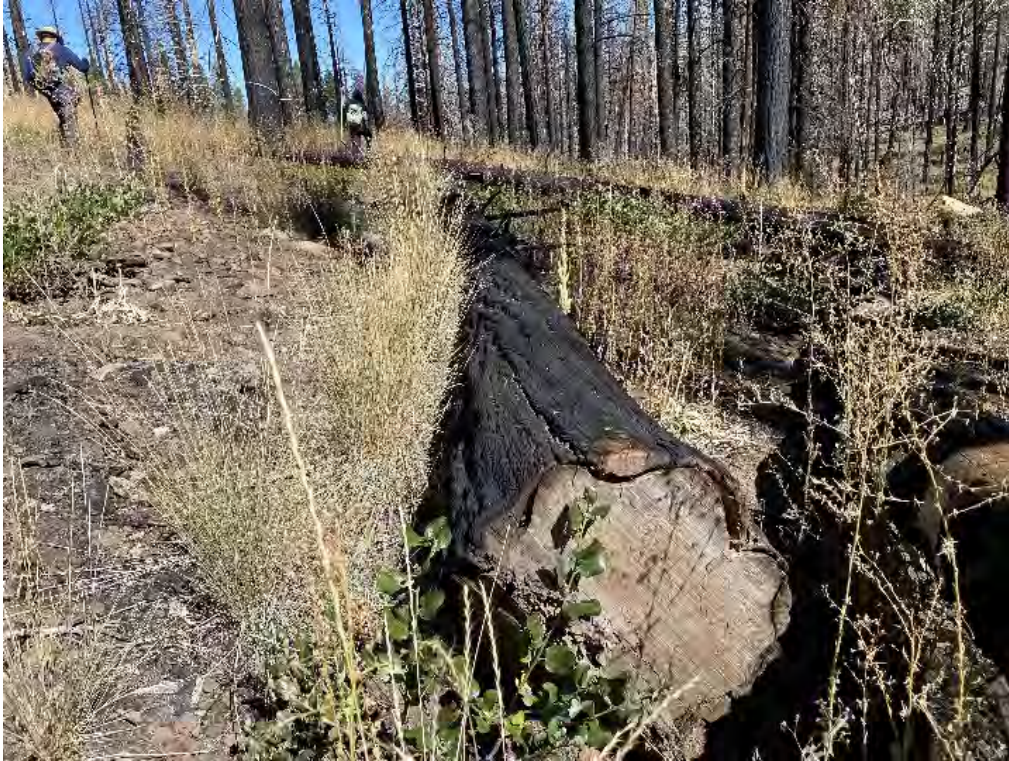
*Figure 1: Successful seeding behind a felled tree*

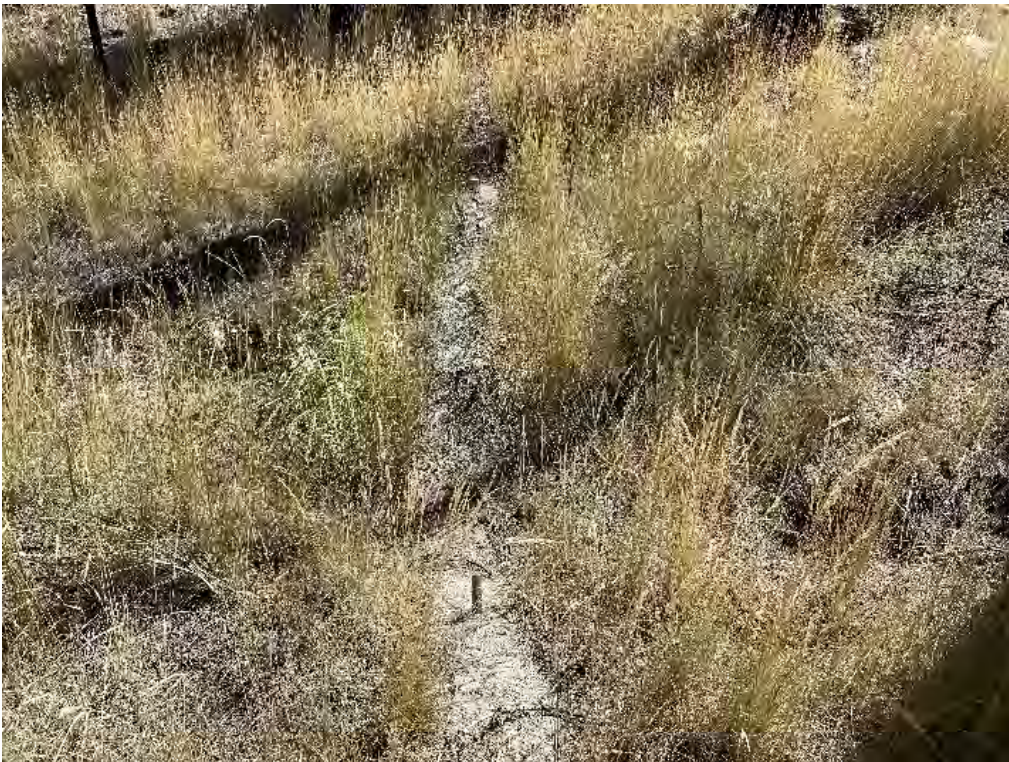
*Figure 2: A wattle that has successfully captured sediment, with thriving seeded grasses on either side*

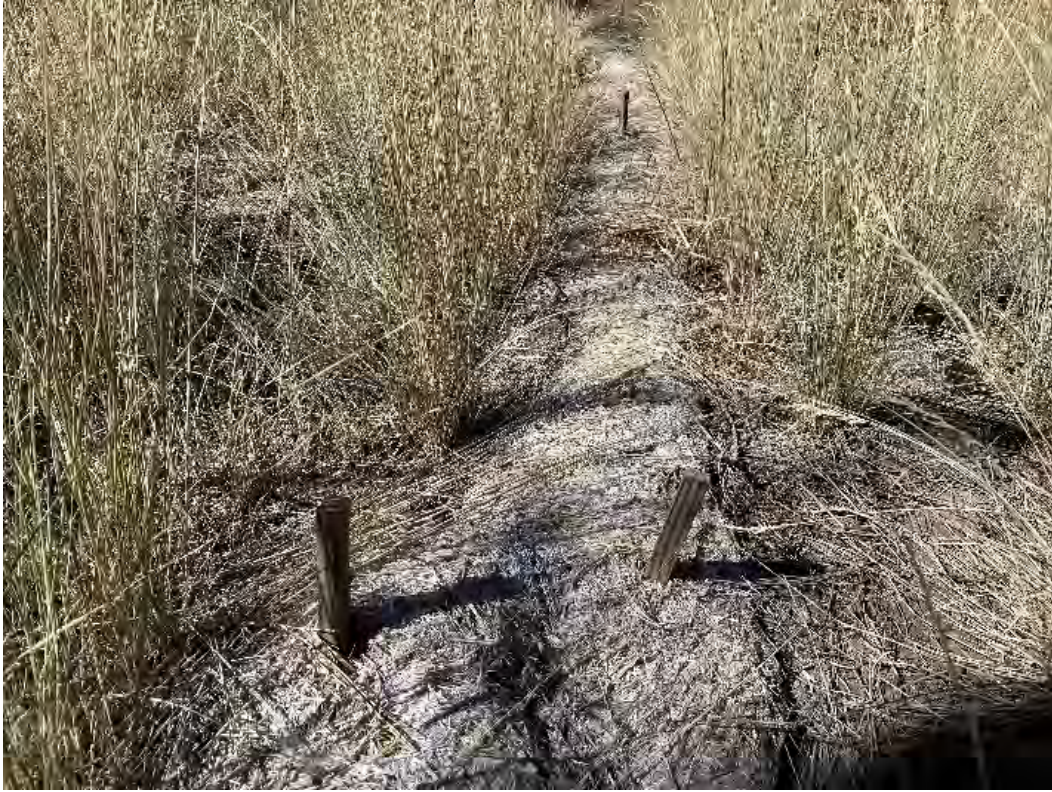
*Figure 3: A wattle that is nearly level with the sediment it has captured*

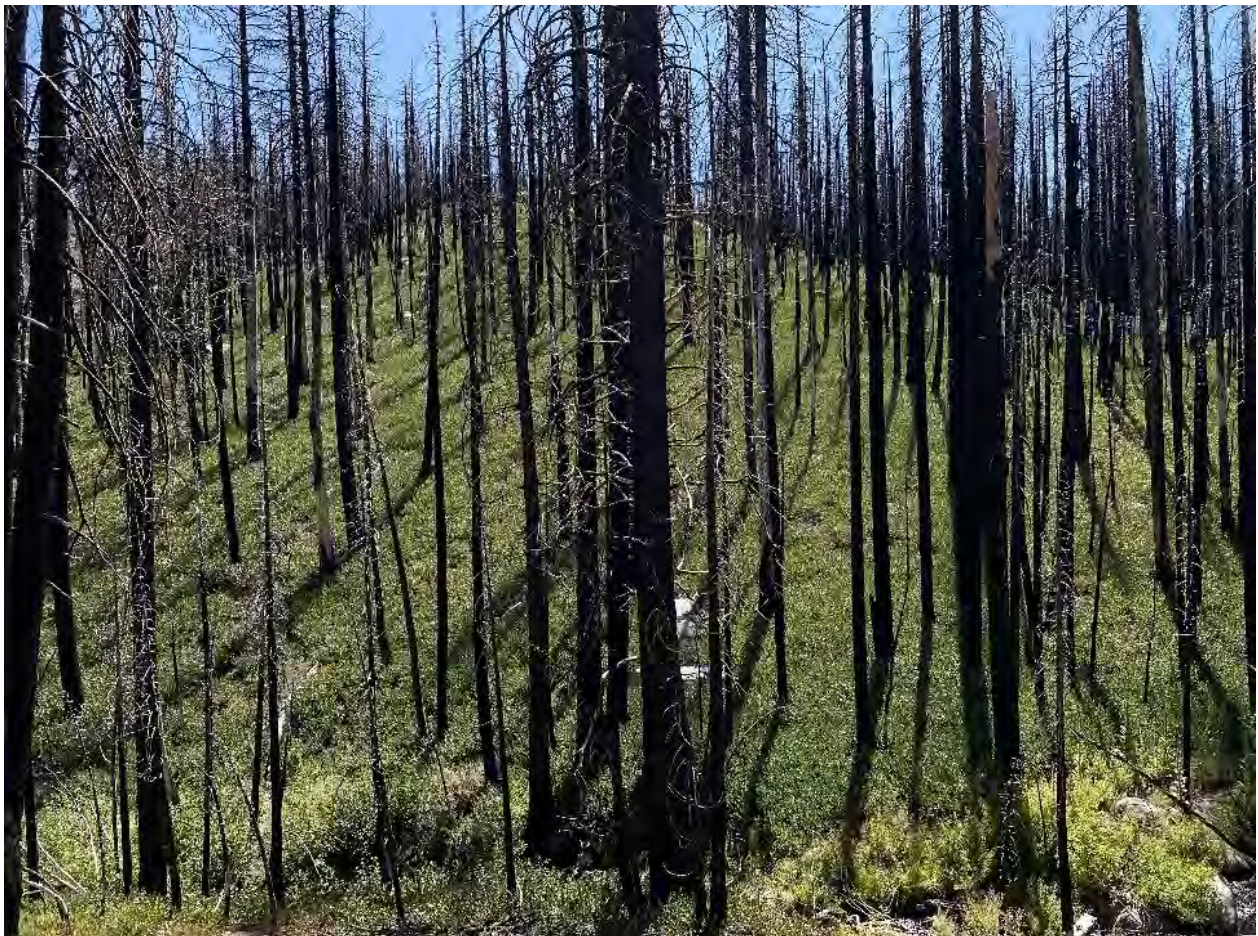
*Figure 4: Ceanothus carpets the floor of a forest of burned trees in the Mokelumne Wilderness*

The dense growth of snowbrush ceanothus depicted in Figure 4 is a stage in forest succession known as the early seral shrub layer. Snowbrush ceanothus growth is prompted by fire,

regenerating from seed that is dormant in the ground until germinated by heat from a fire (Anderson 2001). “Where its seeds are present in soil, snowbrush ceanothus may dominate early seral growth following ‘medium or hot’ fire. Snowbrush ceanothus also sprouts vigorously from the root crown after fire....Fire creates conditions more favorable for snowbrush ceanothus by removing the overstory.... When conifers overtop the shrublands, snowbrush ceanothus may die out because of reduced light intensities in the forest understory” (Anderson 2001). This suggests that the current increased growth and successful establishment of snowbrush ceanothus within the Musser and Jarvis watershed post-Tamarack Fire is expected and can be considered normal forest succession. It also suggests that as forest succession progresses and overstory canopy develops, this dense shrub layer may begin to die off.

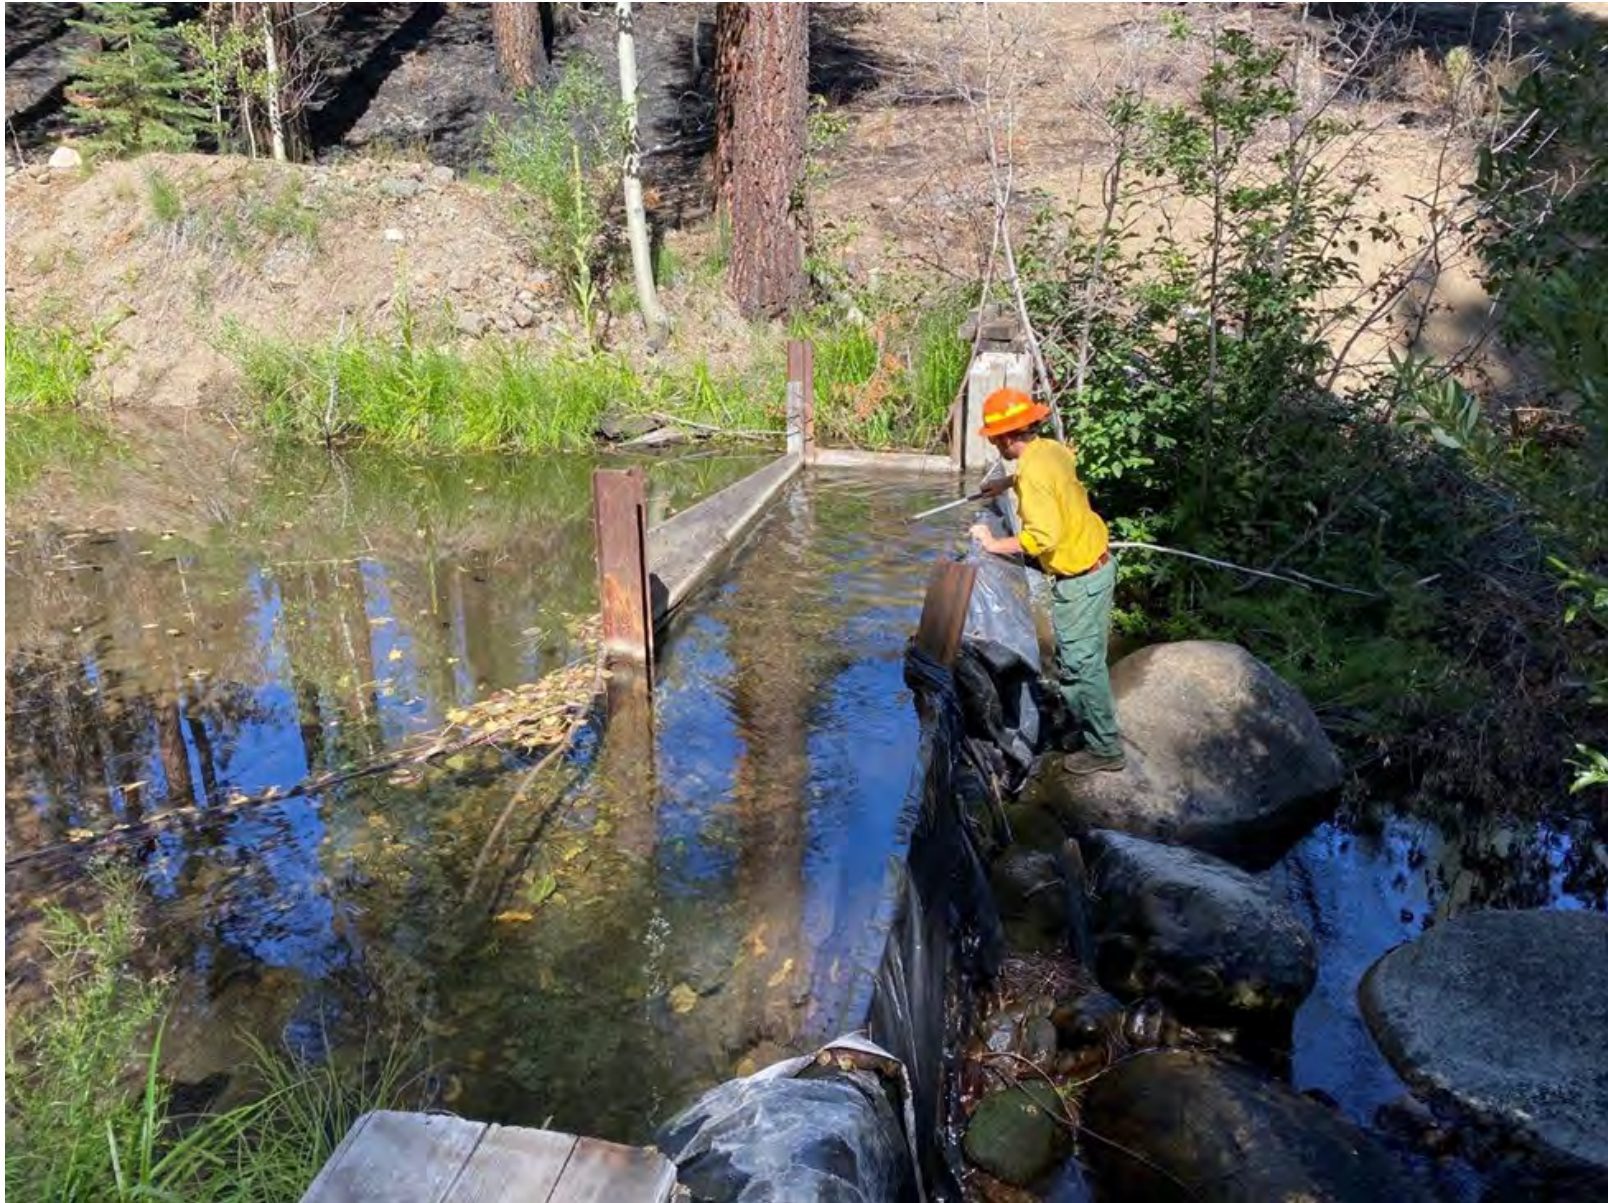
Pre-Tamarack Fire, the intake structure on Musser and Jarvis Creek consisted of a dam and a 14” pipe that extended into the upstream pond created by the dam. The pond measured about 30’ long x 20’ wide x 3’ deep (Appendix C, Photo 1). It was excavated annually under a routine maintenance schedule to remove settled materials that had accumulated. The dam itself consisted of a concrete dam with extension boards that could be adjusted to raise or lower the depth of the pond. The creek water in the intake pond either went into the intake pipe or spilled over the dam and proceeded downstream in its natural stream course. The flow control to the water plant was either on or off.

*Photo 1: Pre-Tamarack Fire, the intake structure on Musser and Jarvis Creek consisted of a dam and a 14" pipe that extended into the upstream pond created by the dam. The pond measured about 30' long x 20' wide x 3' deep. Photo from BAER Report.*

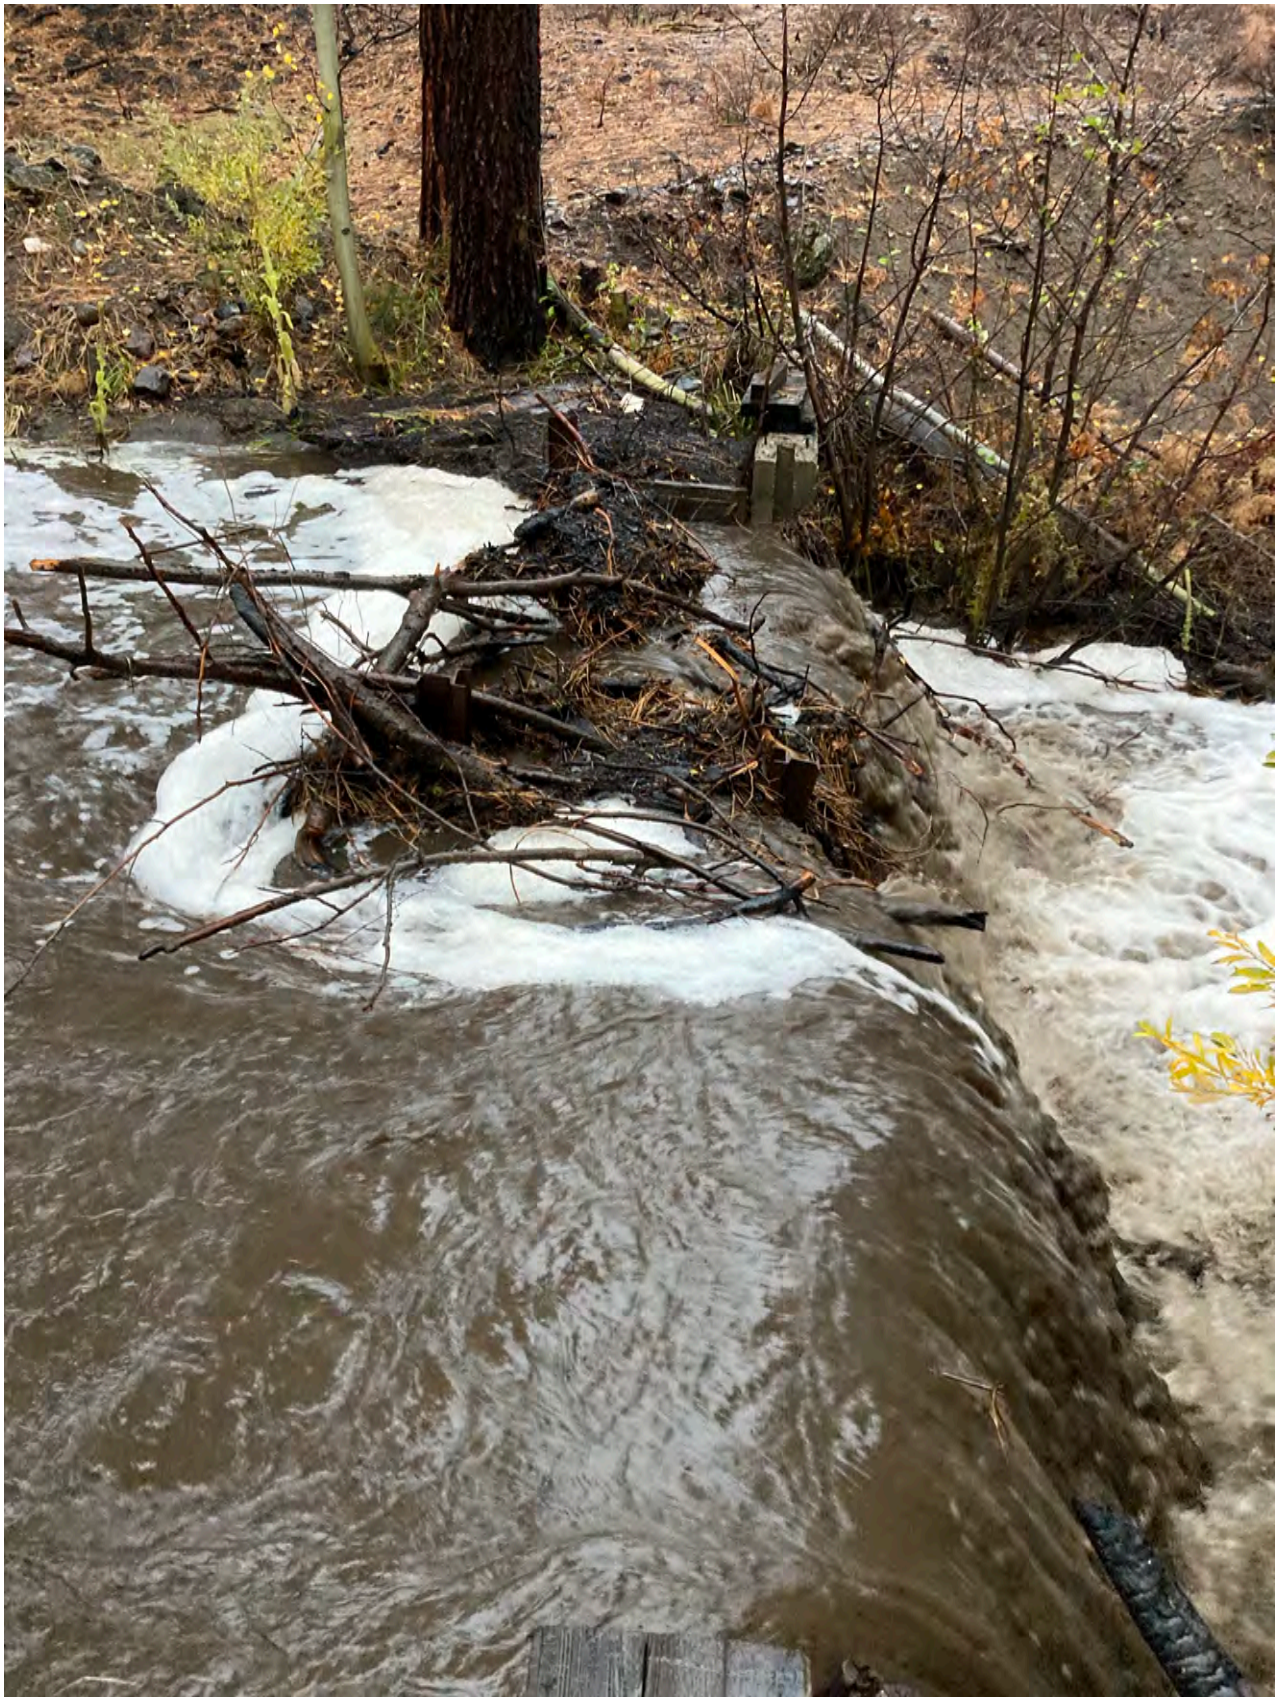
After the Tamarack Fire, excessive sediment composed of sand and decomposed granite was entrained in the water due to erosion runoff, ultimately depositing in the intake pond. The sediment flow was excessive to the degree that the intake pond would completely fill with sediment within 1-2 weeks. The new level of maintenance was a stark change from the previously required annual excavation. In October of 2021 a flash flood occurred in the Markleeville area including the Musser and Jarvis watershed. Debris from the flash flood covered the dam and intake structure, and sediment filled the intake pipe (Appendix C, Photo 2). This required mechanical removal of the debris and cleaning of the intake pipe. A bypass pipe was installed to allow easier cleaning if the intake pipe filled in the future. After flood cleanup the pond continued to accumulate sediment, and excavating the pond every two weeks was not feasible. It was determined that the pond could not be maintained, and that the intake dam needed modification to permit sediment flow through the dam.

*Photo 2: In October of 2021 a flash flood occurred in the Markleeville area including the Musser and Jarvis watershed. Debris from the flash flood covered the dam and intake structure, and sediment filled the intake pipe.*

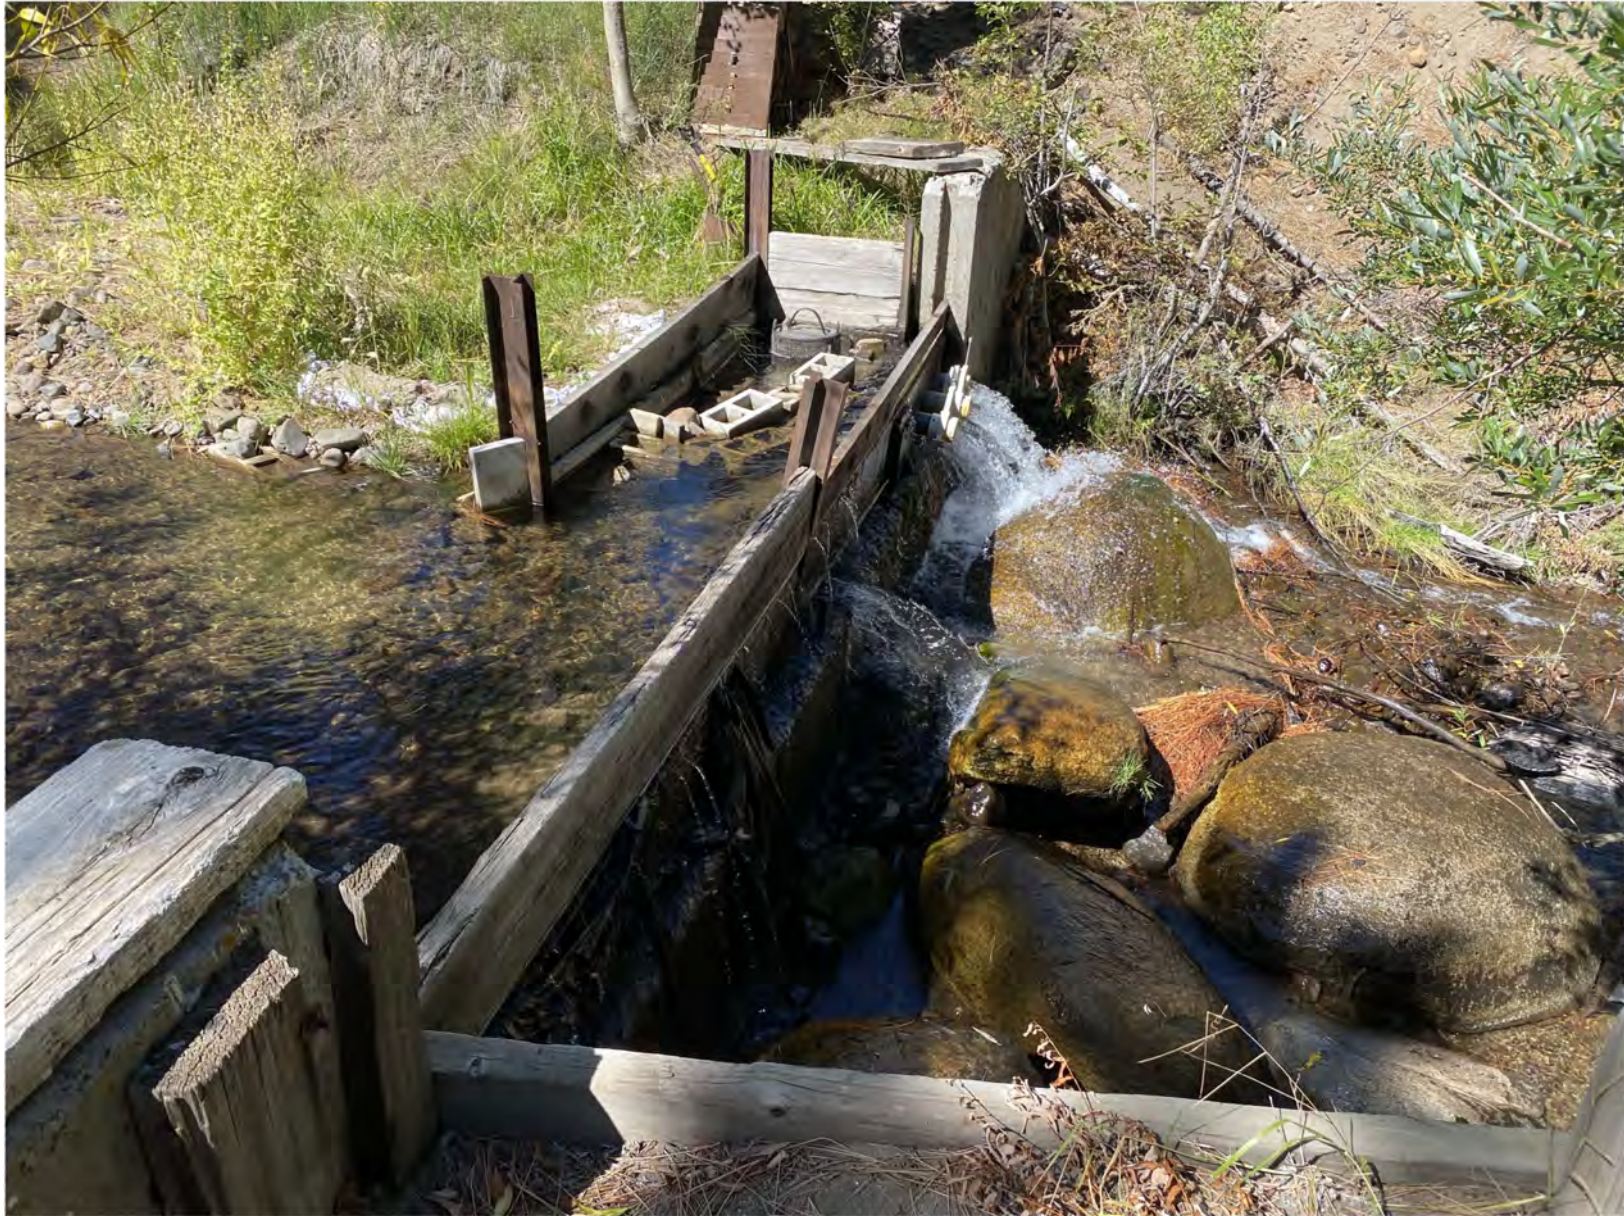
These solutions significantly improved the operation of the intake (Appendix C, Photo 3). However, during times of high debris flows (e.g., after rainstorms), the three pipes frequently become blocked with sticks and pinecones, preventing sediment and debris from flowing through the dam. During these times, sand and decomposed granite accumulate, blocking the intake pipe within a day. Sometimes this requires maintenance every 1-3 days. As of three years after restoration work, the maintenance required is less frequent, but the entire intake can still become blocked.

*Photo 3: Image of MWC's intake structure from September 26, 2024, depicting modifications that have been made to the intake dam following the 2021 Tamarack Fire.*

- Allowing the pond to completely fill with sediment and the stream to flow naturally to the dam, protecting the intake pipe from the main stream flow behind a gravel bar
- Modifying the dam boards immediately downstream of the intake pipe by installing three 4-inch pipes with gate valves about 8” below the water surface and at the top of the intake pipe
- Installing a remote camera to monitor the status of the intake
- Installing concrete blocks in the path from the stream to the intake—The purpose of the blocks is to increase and maintain the water velocity to entrain sediment in the water flowing to the three pipes, thereby allowing the sediment to flow through the dam and directing the water with less sediment to flow to the intake pipe.
