Musser and Jarvis Watershed Restoration 2022 Monitoring Report

July 27, 2023

Musser and Jarvis Watershed Restoration Photo Monitoring

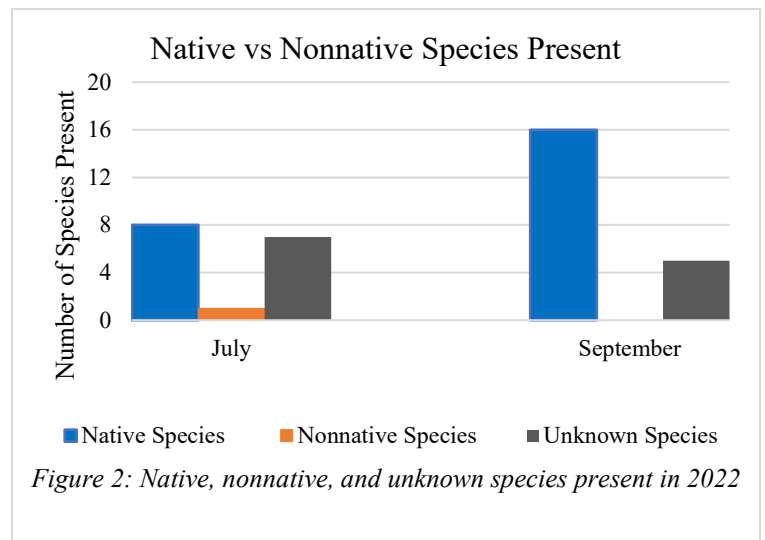
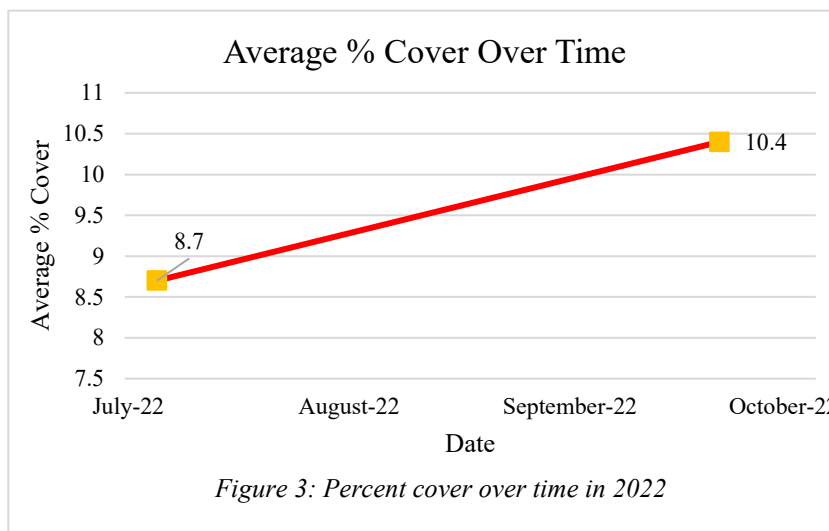
On June 5, 2022, 19 native species, 1 nonnative species, and 7 unknown species were found within the vegetation monitoring plots. September 22, 2022, had increased numbers of native species and decreased numbers of invasive/unknown species, with 16, 0, and 5 species respectively (see Figure 2). The percent cover data from 2022 reflects the changes seen in the photo points with an increase in average percent cover from 8.7% to 10.4% (see Figure 3). Out of the seeded native grass species, 4 were present.

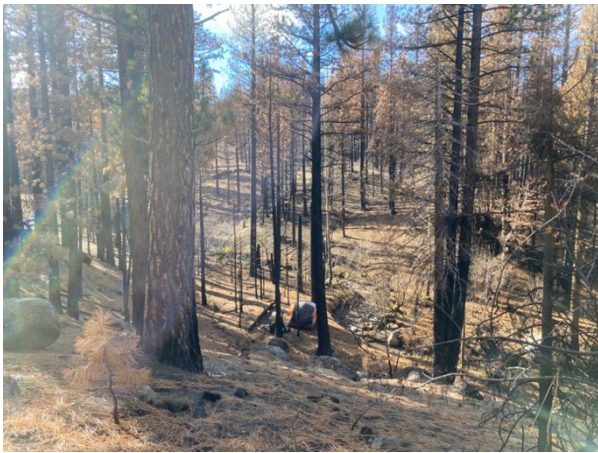
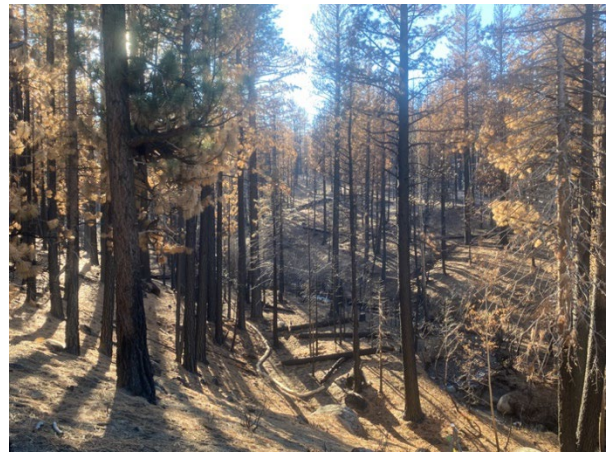
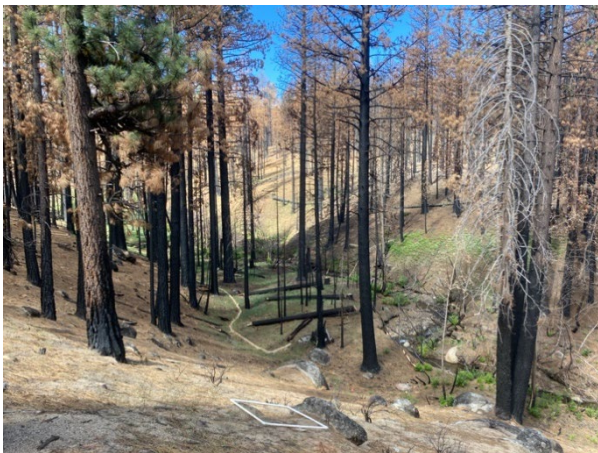
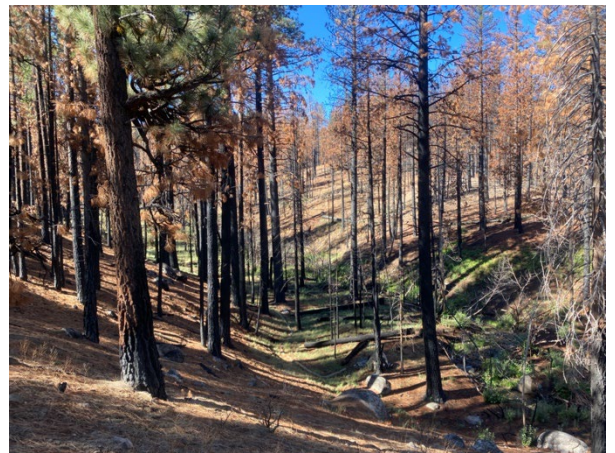
MJPP1 (seeding with wattles):

November 19, 2021 (Before restoration)

December 3, 2021 (After Restoration)

July 5, 2022

September 22, 2022

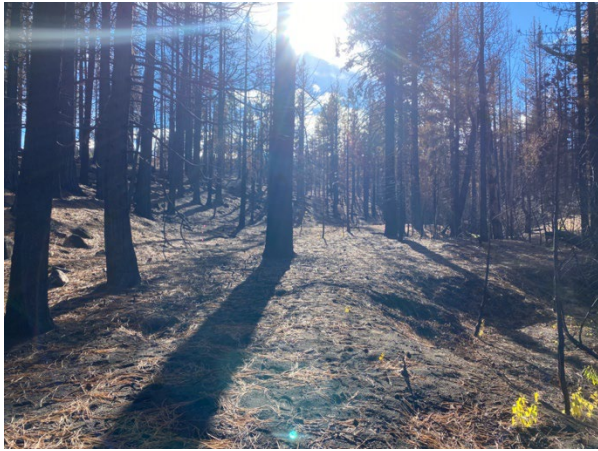
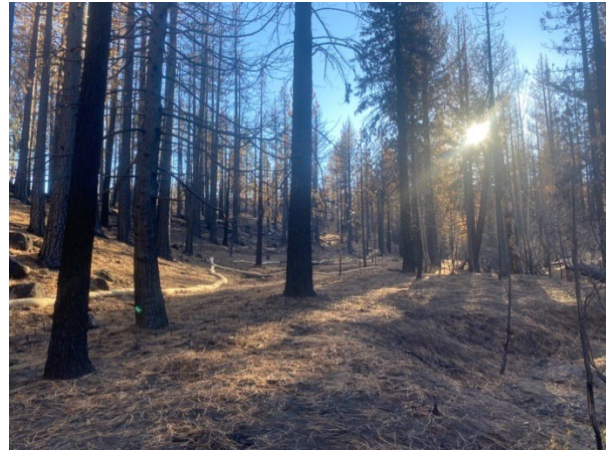
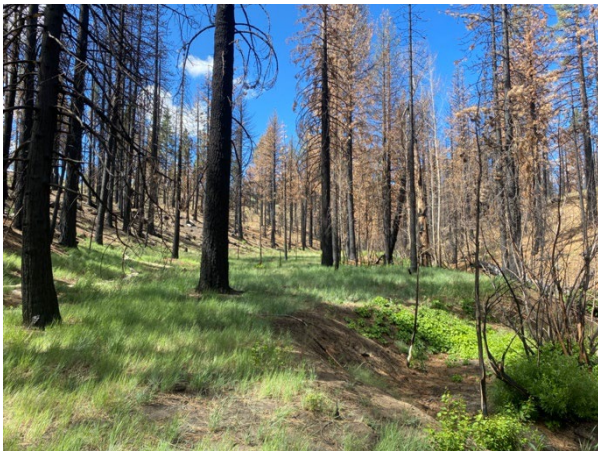
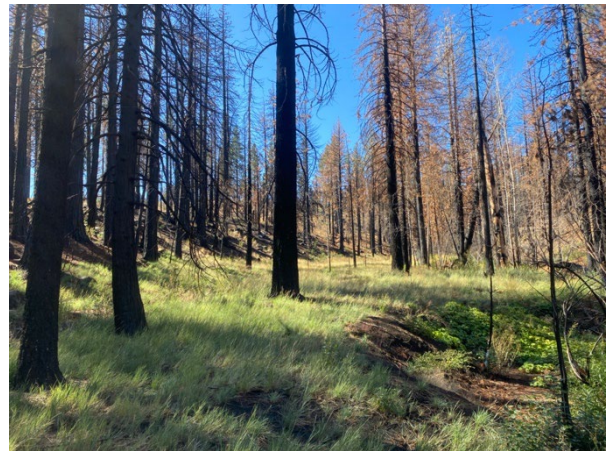
MJPP3 (seeding with wattles):

November 19, 2021 (Before Restoration)

December 3, 2021 (After Restoration)

July 5, 2022

September 22, 2022

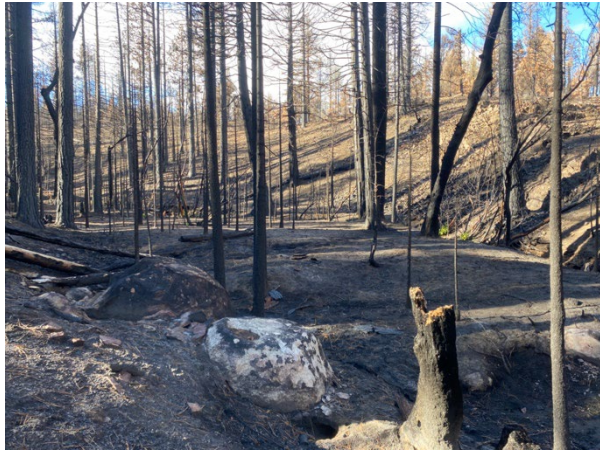
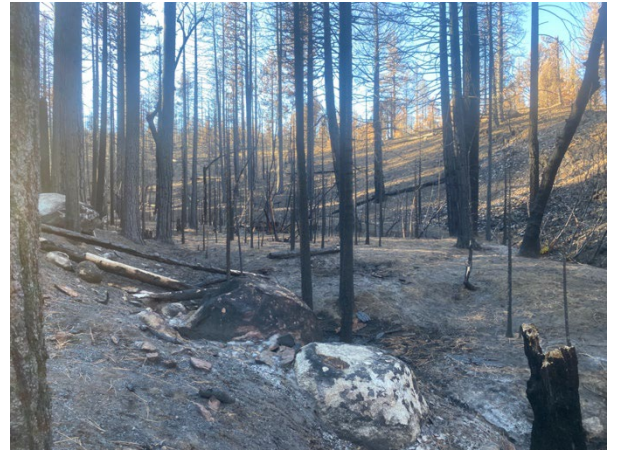
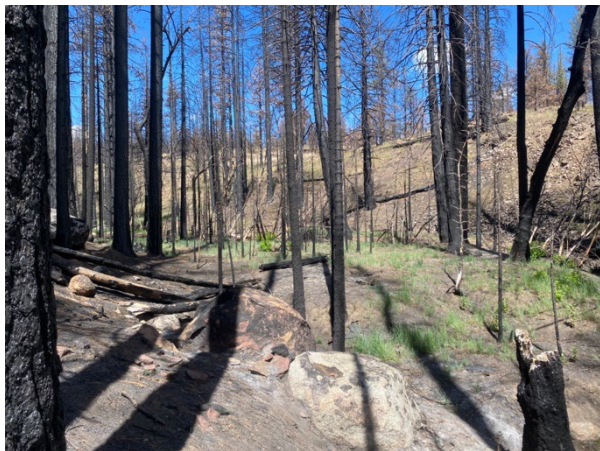
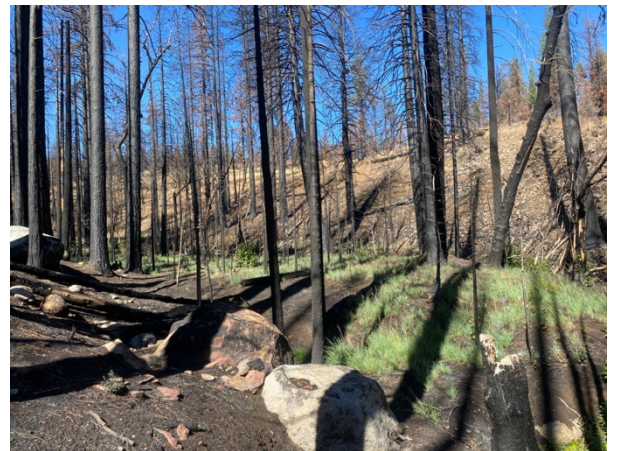
MJPP8 (seeding without wattles):

November 19, 2021 (Before Restoration)

December 3, 2021 (After Restoration)

July 5, 2022

September 22, 2022

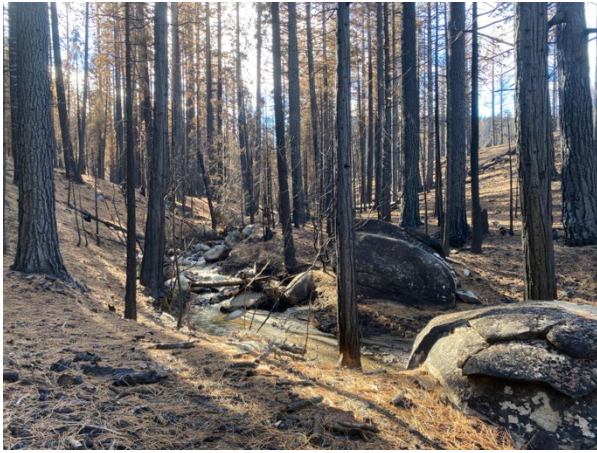
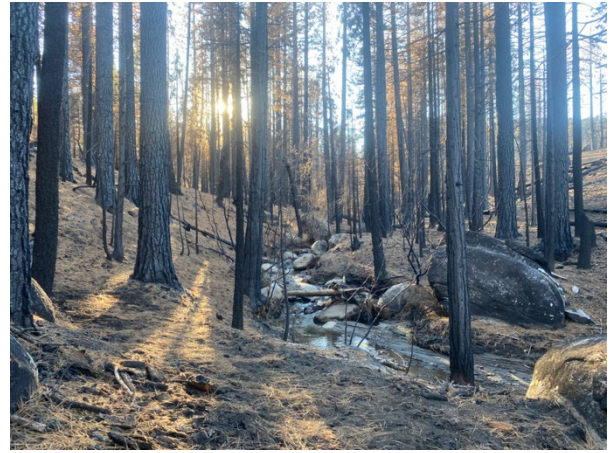
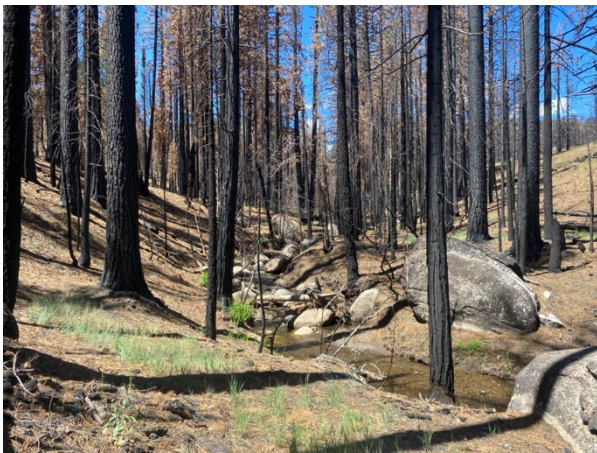
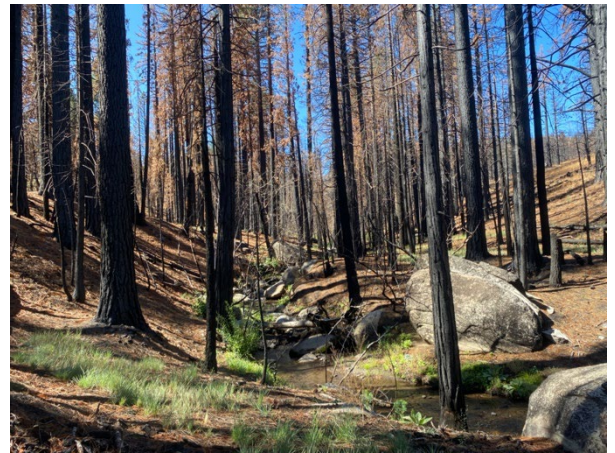
MJPP10.1 (seeding without wattles):

November 19, 2021 (Before Restoration)

December 3, 2021 (After Restoration)

July 5, 2022

September 22, 2022

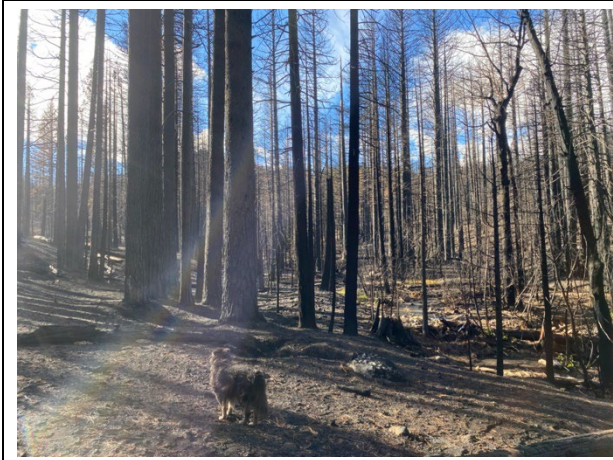
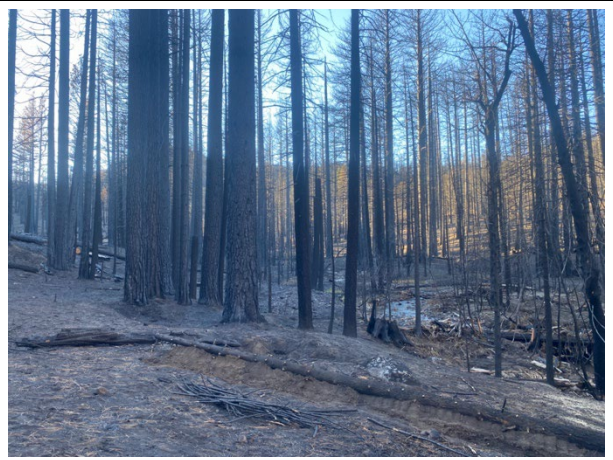
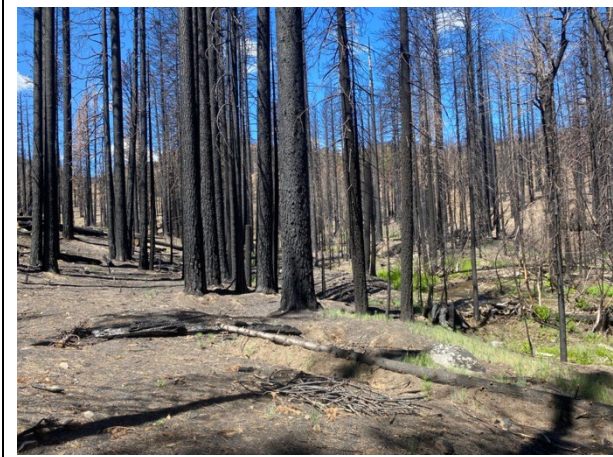
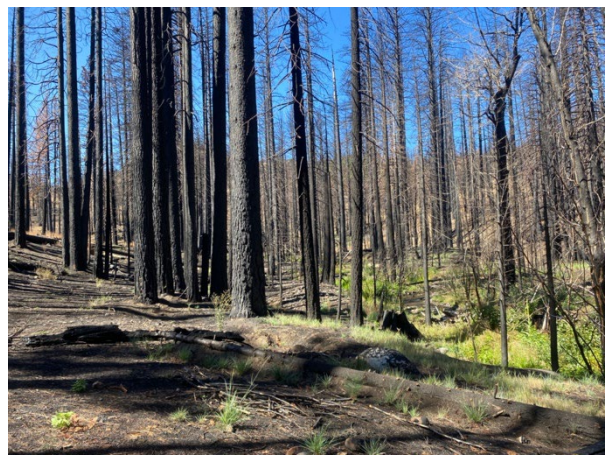
MJPP12 (tree felling):

Noticeable growth is detected in both the seeded and non-seeded areas, with graminoids (herbaceous plants with grass-like features) being the prominent vegetation type in seeded areas and forbs in the non-seeded areas. Comparing the selected photo points demonstrates the most notable difference between December and June (see Appendix B), and percent cover continued to increase in September. Areas that were seeded have the highest percent cover while high-severity burn areas had the lowest (see Appendix C). The planted trees have persisted well over the summer, and growth is visible (for example, see MJPP 14 [July and September] in Appendix B). Soil is beginning to settle behind the felled trees, and significant bank erosion has not been observed, even with a significant storm event in August 2022 (see MJPP 12 in Appendix B). The south slope, despite no treatment, is recovering with few invasive species.

November 19, 2021 (Before Restoration)

December 3, 2021 (After Restoration)

July 5, 2022

September 22, 2022

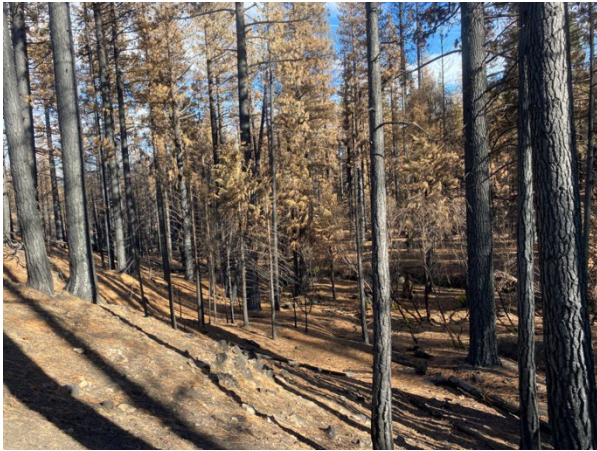
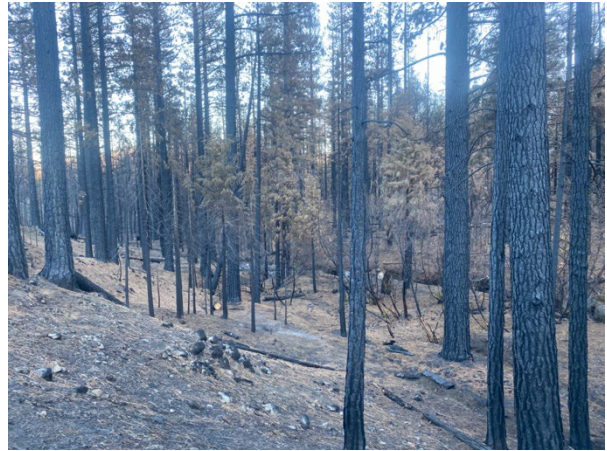
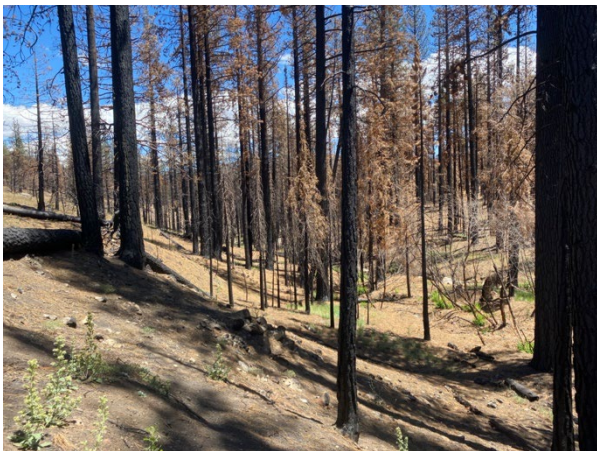
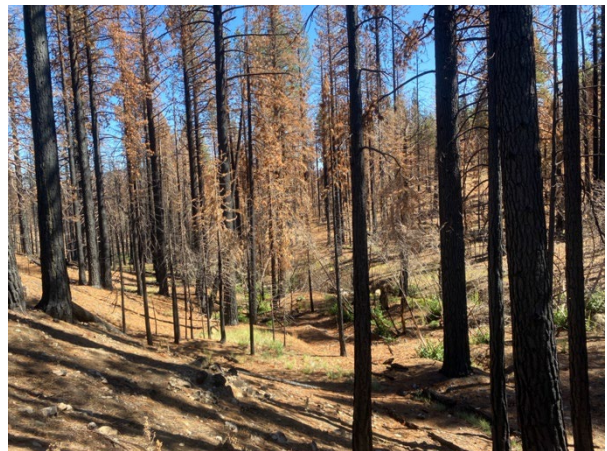
MJPP19 (no treatment):

November 19, 2021 (Before Restoration)

December 3, 2021 (After Restoration)

July 5, 2022

September 22, 2022

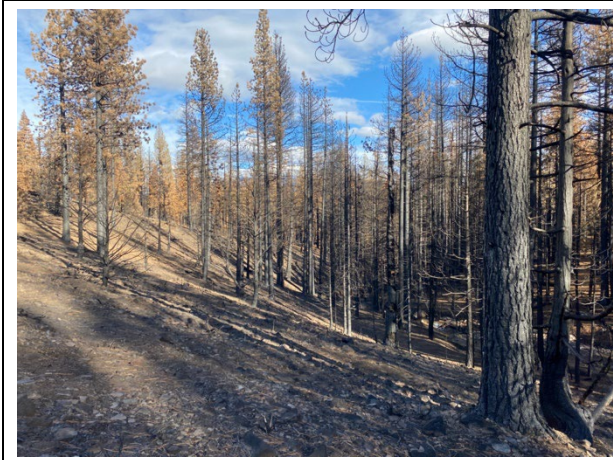
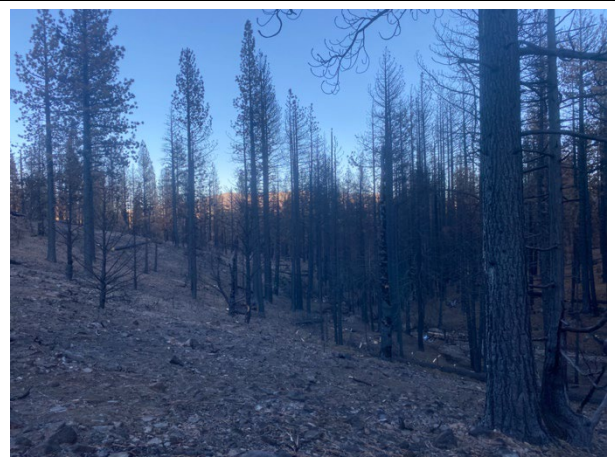
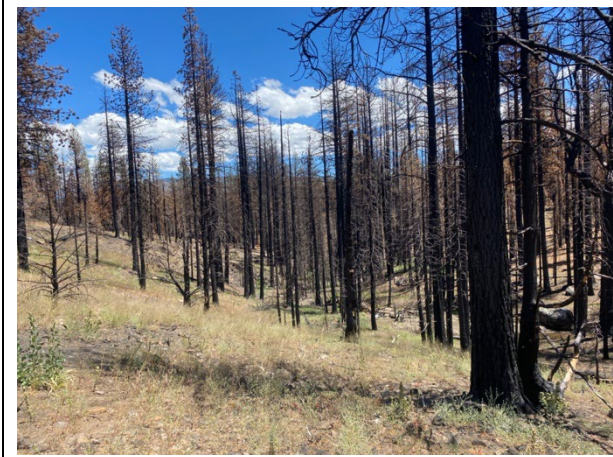
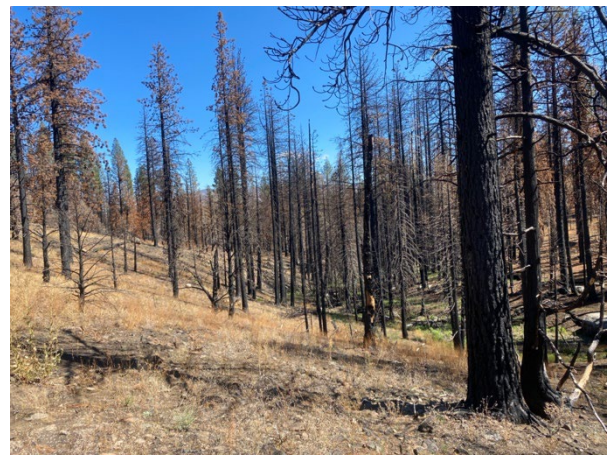
MJPP20 (no treatment):

November 19, 2021 (Before Restoration)

December 3, 2021 (After Restoration)

July 5, 2022

September 22, 2022
