Re: Hope Valley Restoration and Aquatic Habitat Enhancement Project
General 401 Water Quality Certification WDID# 6A022004007 Annual
Monitoring Report

Hope Valley Restoration and Aquatic Habitat Enhancement Project

2025 Annual Monitoring Report

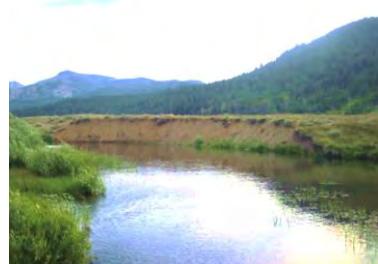
Log Crib Pre-2015 Construction

HVPM 17.0: Looking upstream at Site 2 on river right*

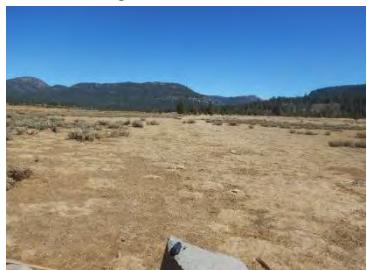
September 28, 2020 (Pre-construction)

HVPM 18.1: At entrance of Site 2 access route near USFS dispersed camping area (*monitoring discontinued in 2021 due to sign off by project partners)

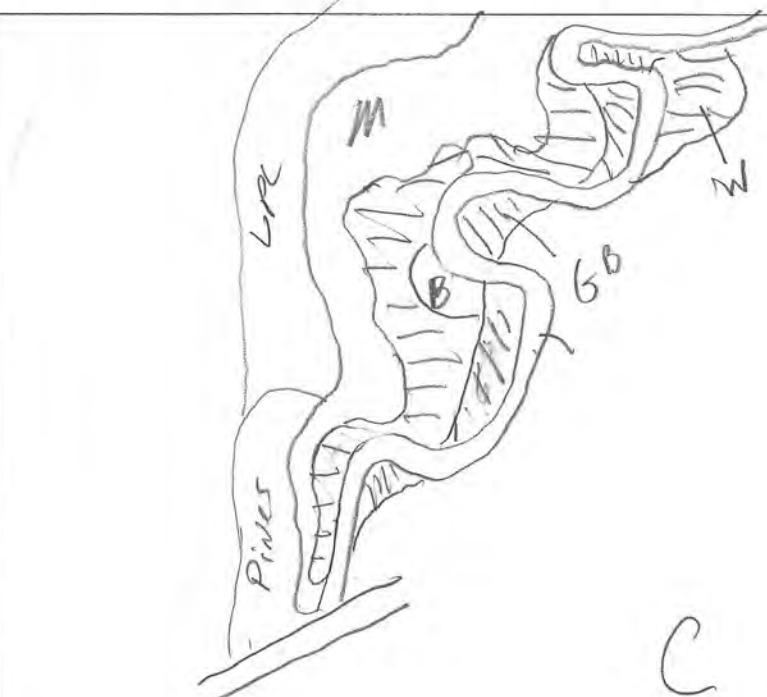
<p>Assigned zones:</p> <ol style="list-style-type: none"> 1) Gravel Bar - early successional 2) Willow (Willow) W willow/Herb understory 3) Barren/Sand (B) (No veg) 4) Meadow (M) 5) Channel (ow) 6) Trees (Pines) Herb/graminoid <i>sodens</i> - <i>laxus</i> / shrub up
--	---
