Re: Hope Valley Restoration and Aquatic Habitat Enhancement Project
General 401 Water Quality Certification WDID# 6A022004007
Annual Monitoring Report

Hope Valley Restoration and Aquatic Habitat Enhancement Project

2021 Annual Monitoring Report

Prepared by Mo Loden, Watershed Program Manager and Rachel Kieffer, Watershed Coordinator

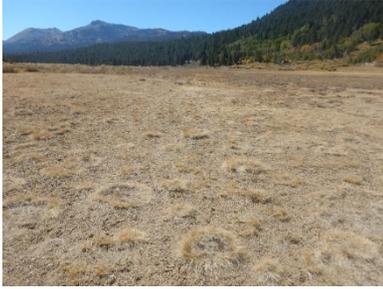
September 28, 2020 (Pre-construction)

HVPM 28.0: Site 2 access route near end at project site
